DRYSCAN

REPORT TYPE: Pre-Purchase Building and Weather
Tightness Inspection

DATE OF INSPECTION: 00/00/2022

Date of Inspection	00/00/2022 at 09:05 AM (13 GMT)
Thermographer	Bryce Hall
Property Address	Auckland.
Property Description	Attached, 2 Storey Dwelling
Exterior Cladding	Brick and Direct Fixed Texture Coated Fibre-cement Board/Harditex type
Roofing Material	Tin Tiles
Joinery	Alloy

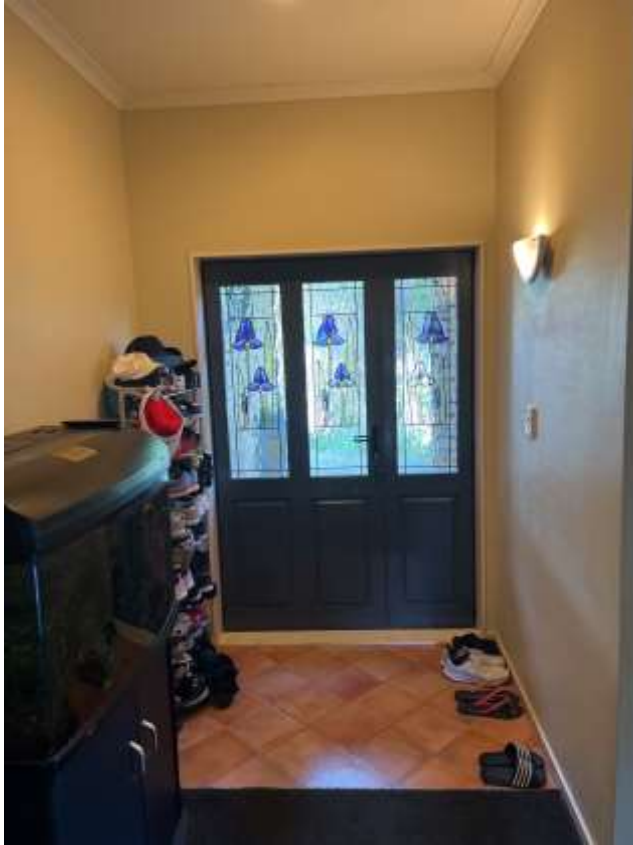
Photo 2

MOISTURE READING %: 10 - 14

THERMAL ANOMALY: No

Moisture readings of 10 - 14 % were obtained throughout the Entry West Wall. There were no thermal anomalies or any other signs of moisture ingress.

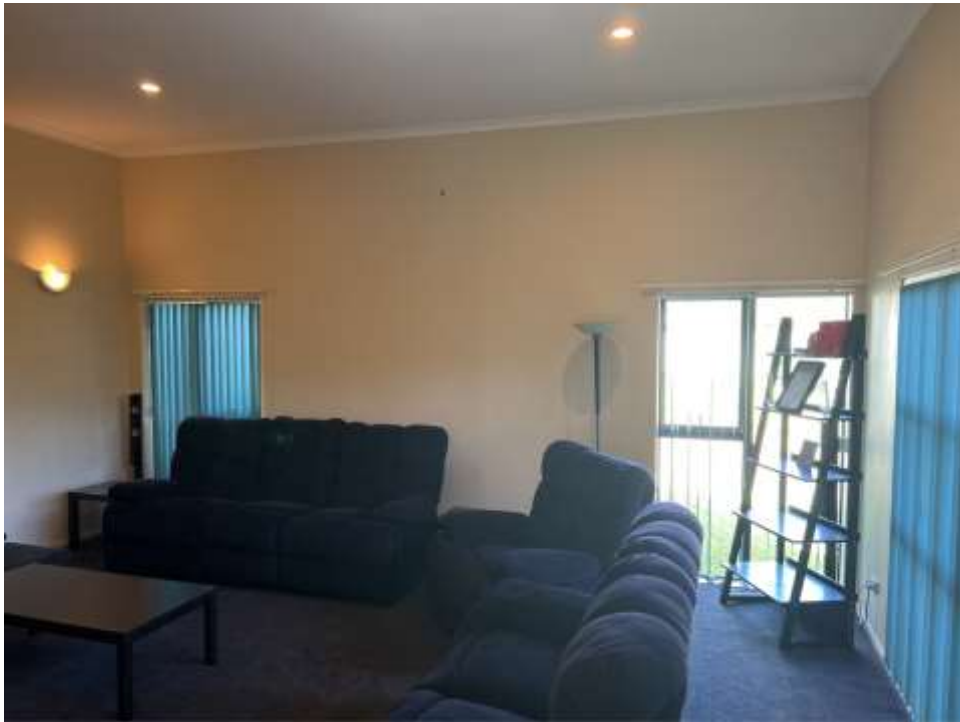
Photo 3

MOISTURE READING %: 11 - 19

THERMAL ANOMALY: No

Moisture readings of 11 - 19 % were obtained throughout the Lounge West Wall. There were no thermal anomalies or any other signs of moisture ingress.

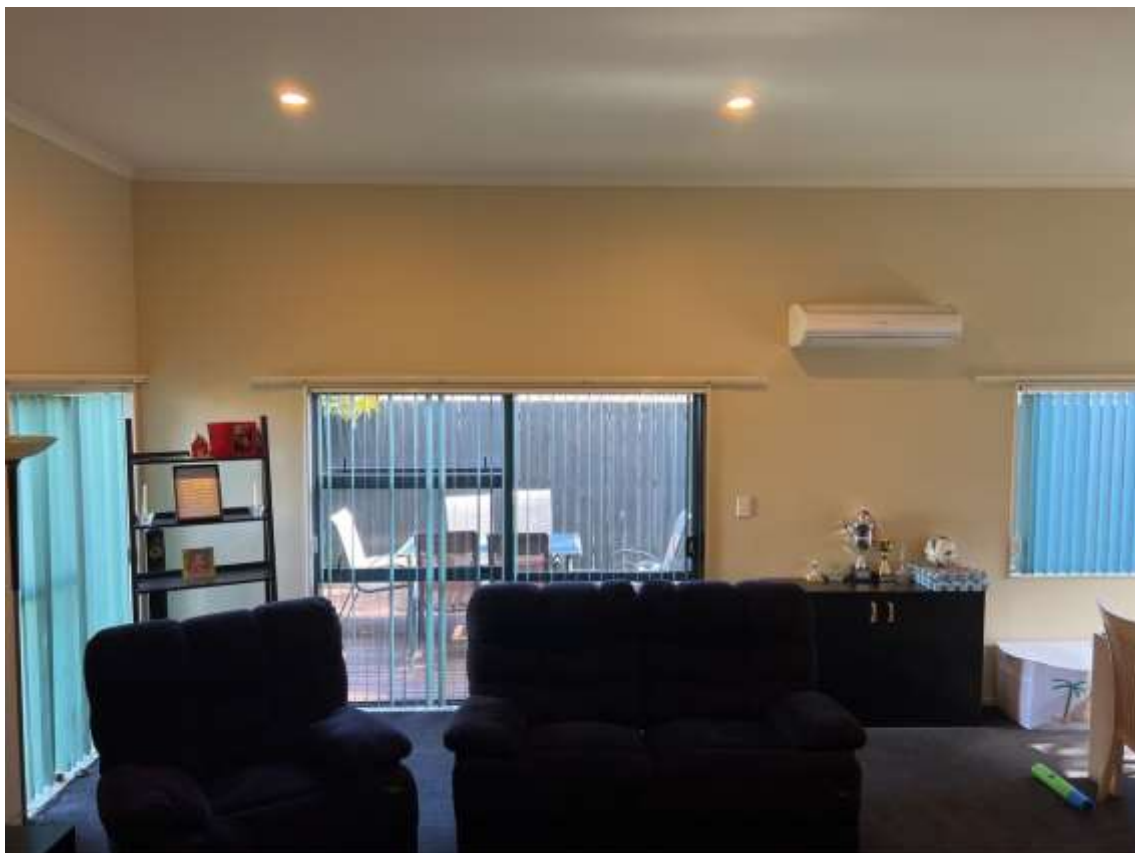
Photo 4

MOISTURE READING %: 12-26

THERMAL ANOMALY: Yes

Soon as Possible

High moisture readings were obtained due to cladding failure, located outside here. Due to this, moisture ingress is tracking down/through the internal wall, giving a reading of 26% at the top above the doors on the right hand side (photos and thermal images 5 to 10).

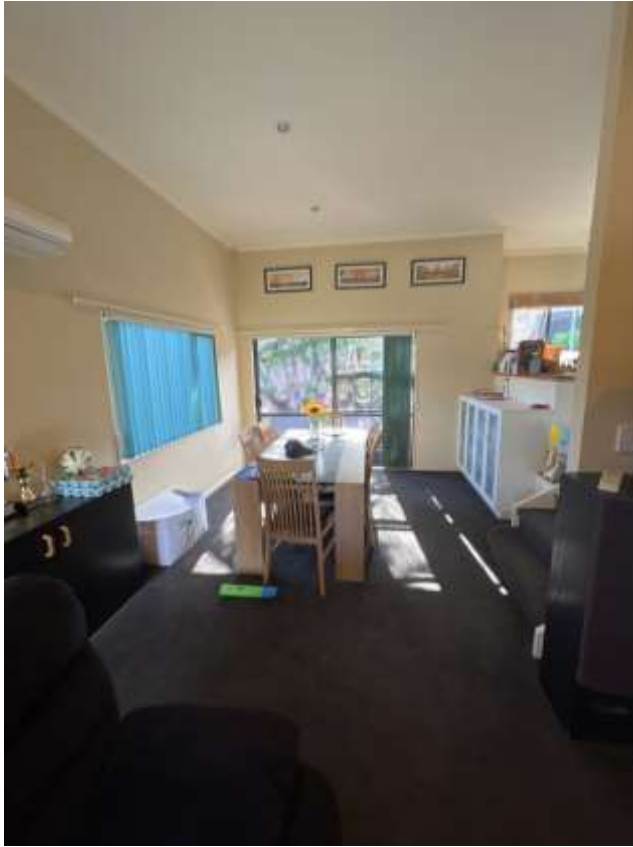
Photo 11

MOISTURE READING %: 12 - 61

THERMAL ANOMALY: Yes

Soon as Possible

High moisture readings were obtained due to waterproofing failure. Due to this, moisture ingress is tracking through the floor slab split level by the steps to the kitchen, giving a reading of 61% at the bottom on the left hand side of the steps (photos and thermal images 12 to 15).

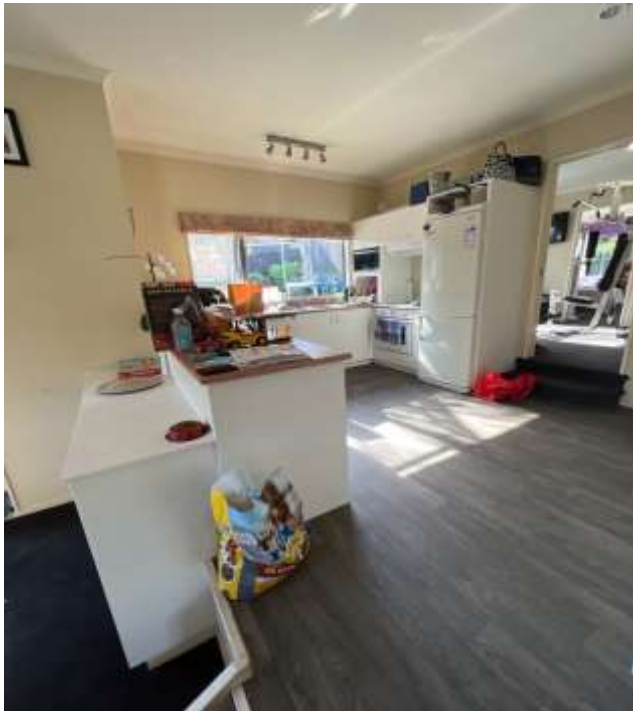
Photo 16

MOISTURE READING %: 11 - 15

Moisture readings of 11 - 15 % were obtained throughout the Kitchen East Wall. There were no thermal anomalies or any other signs of moisture ingress.

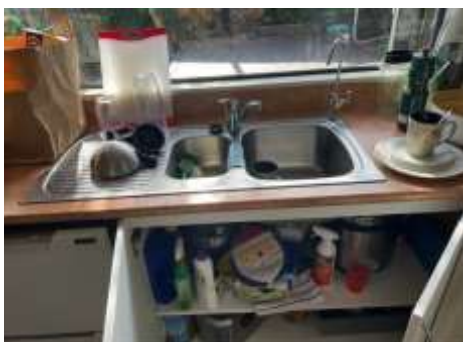
Photo 17

Kitchen Sink Plumbing appears to be in good working order, the rangehood is ducted outside (photos 17 & 18).

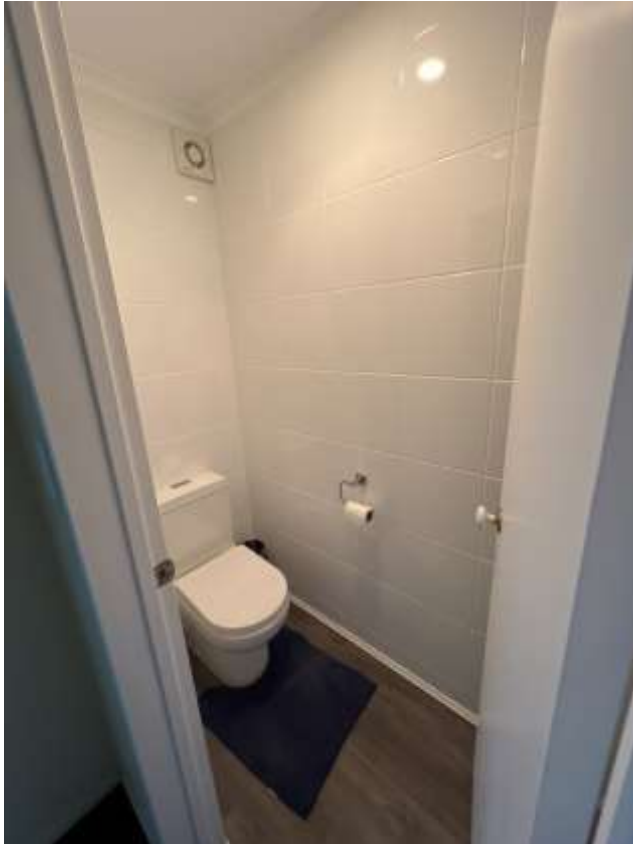
Photo 20

Moisture readings of 12 - 18 % were obtained throughout the Toilet Central Internal Wall. There were no thermal anomalies or any other signs of moisture ingress.

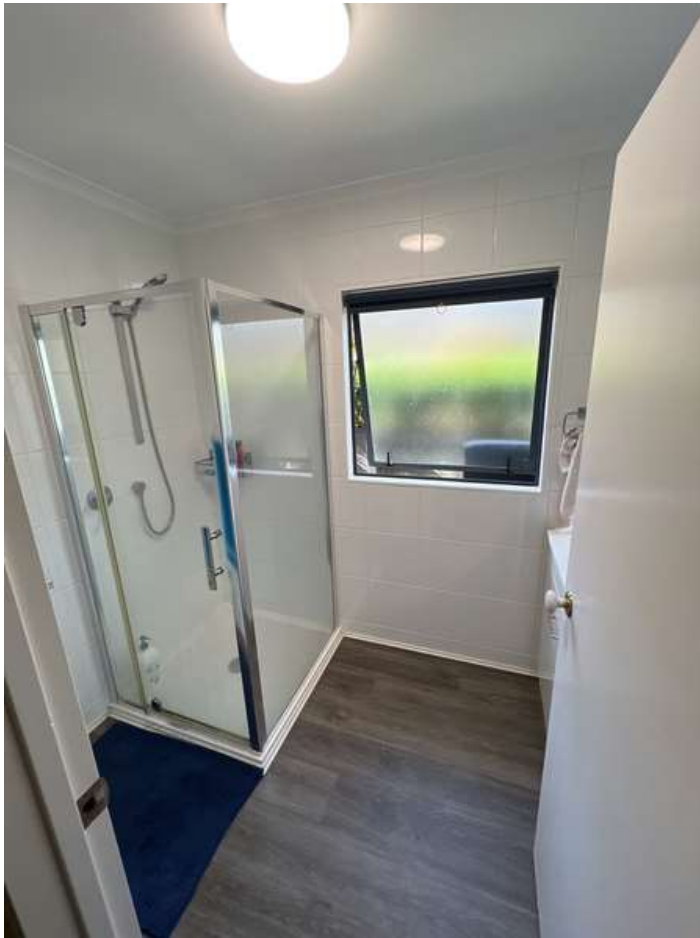
Photo 21

MOISTURE READING %: 15-94

This area has floor to Ceiling wall tiles with high moisture readings were obtained due to a possible pipe or ground clearance failure, located outside here. Due to this, moisture ingress is tracking down/through the internal wall, giving a reading of 94% at the bottom of the wall below the window (photos and thermal images 22 to 25).

A hot water shower test was carried out to determine if the junctions of the shower were failing. The shower is in good condition.

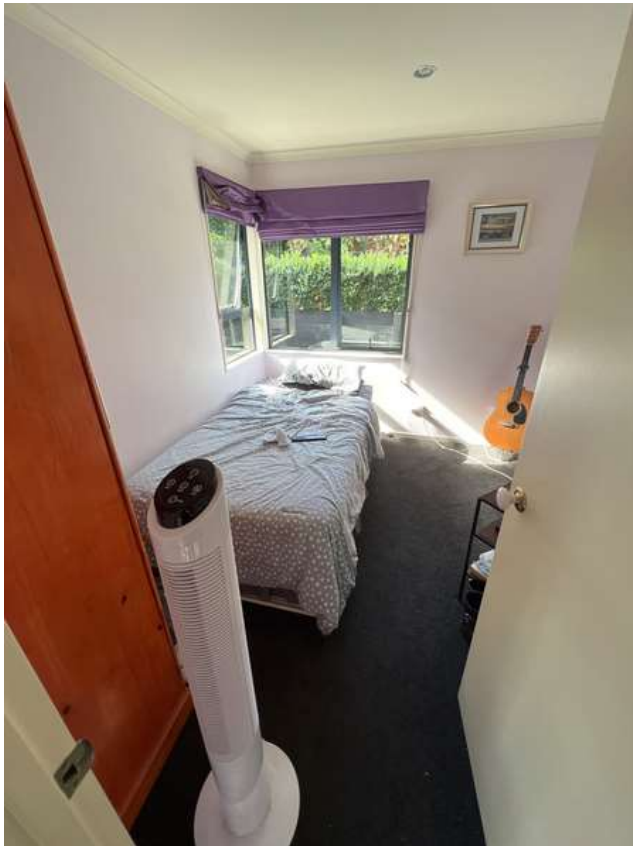
Photo 26

Moisture readings of 12 - 19 % were obtained throughout the Bedroom 1 South-East Wall. There were no thermal anomalies or any other signs of moisture ingress.

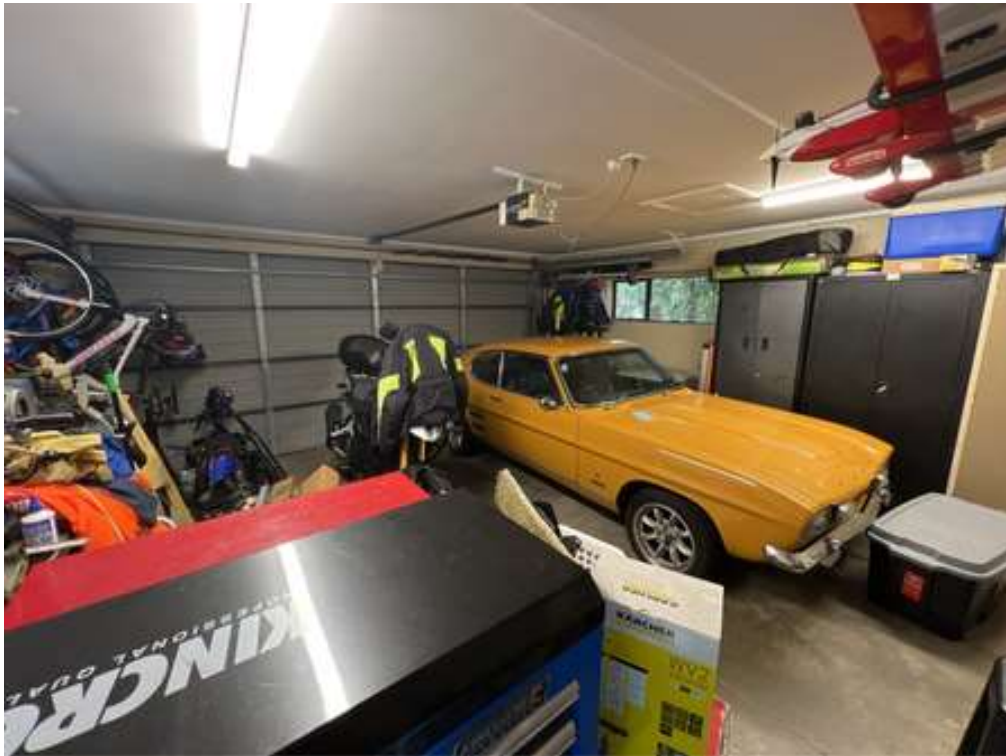
Photo 27

Moisture readings of 12 - 19 % were obtained throughout the Garage North-West Wall. There were no thermal anomalies or any other signs of moisture ingress.

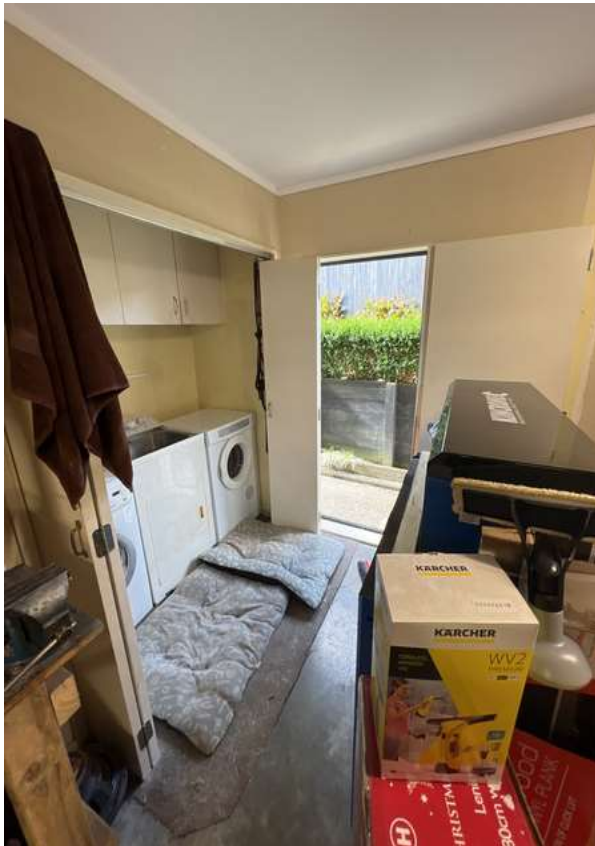
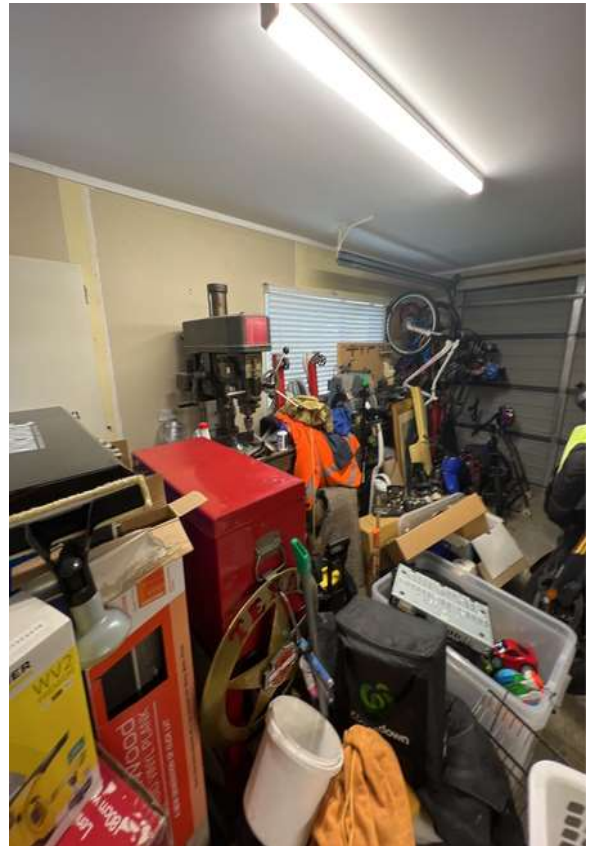
Moisture readings of 12 - 19 % were obtained throughout the Garage/Laundry South Wall. There were no thermal anomalies or any other signs of moisture ingress.

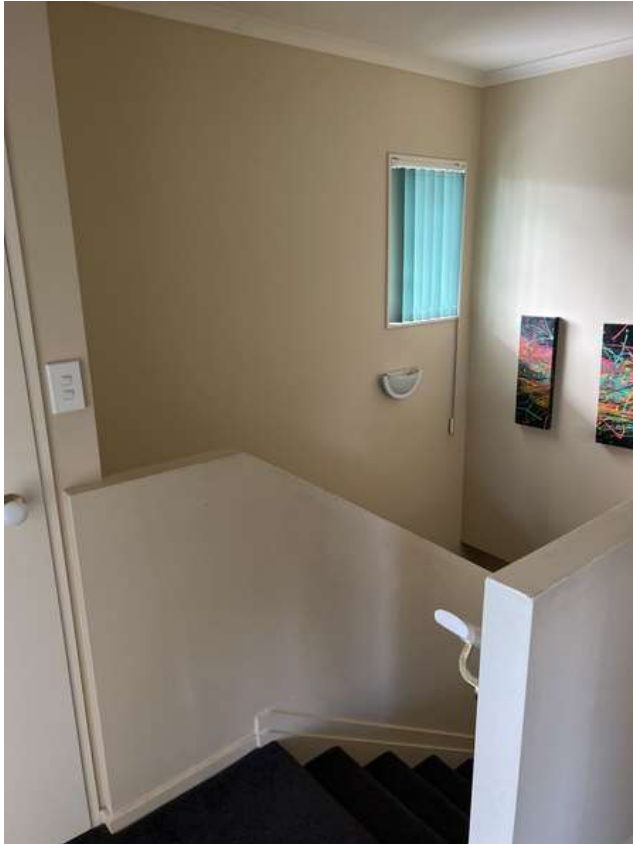
Photo 30

Moisture readings of 10 - 14 % were obtained throughout the Stairwell East Wall. There were no thermal anomalies or any other signs of moisture ingress.

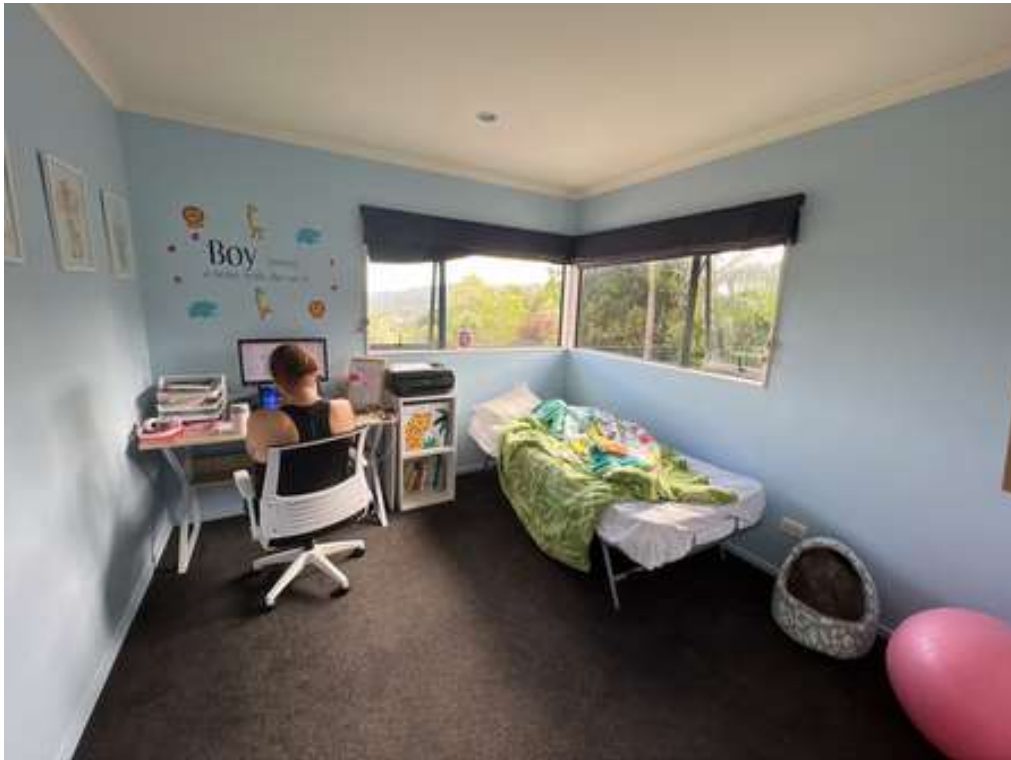
Photo 31

Moisture readings of 10 - 17 % were obtained throughout the Bedroom 2 North-East Wall. There were no thermal anomalies or any other signs of moisture ingress.

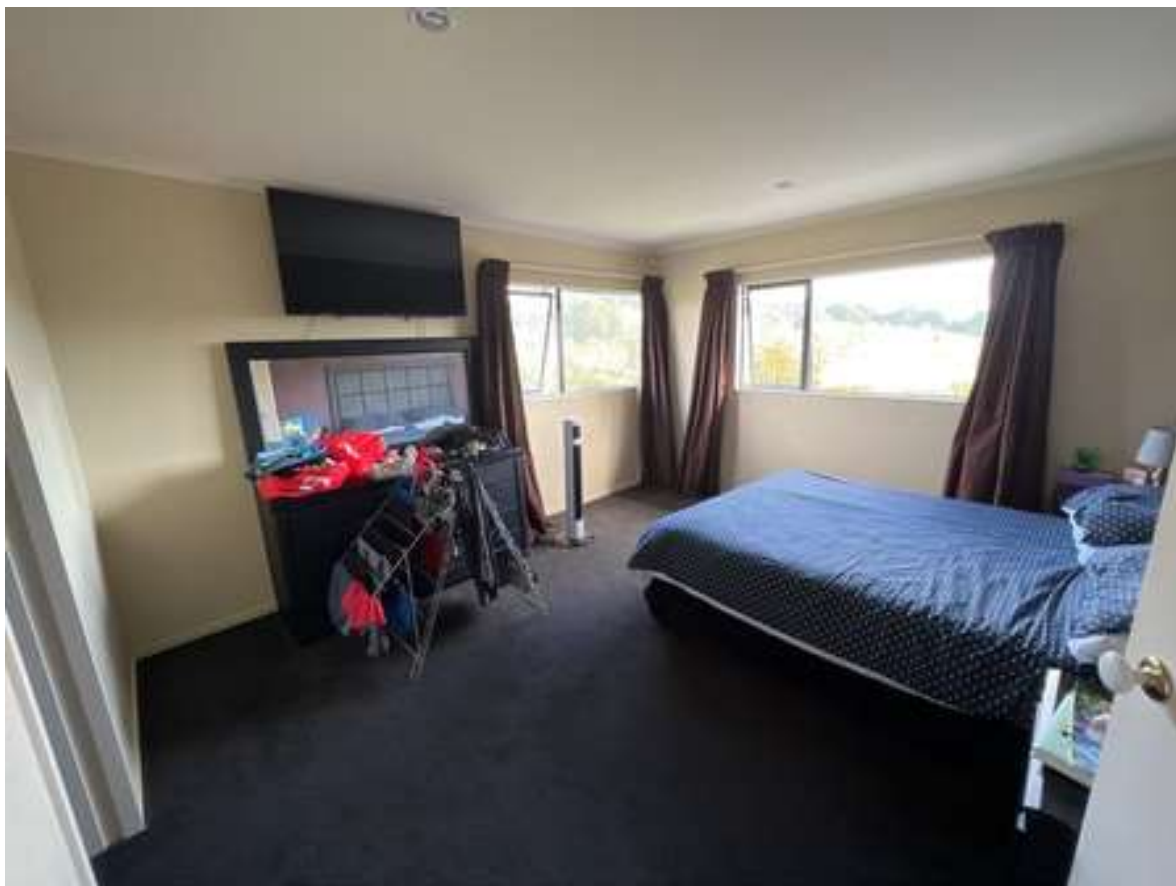
Photo 32

MOISTURE READING %: 11-28

High moisture readings were obtained due to a joinery failure, located outside here. Due to this, moisture ingress is tracking down/through the internal wall, giving a reading of 28% under the north wall window on the left hand side (photos and thermal images 33 to 35).

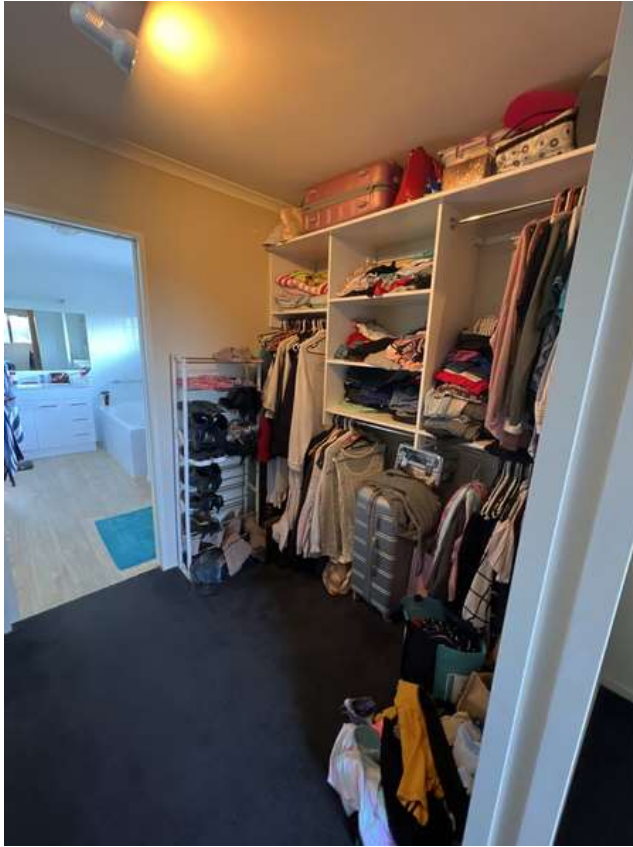
Photo 36

Moisture readings of 09 - 14 % were obtained throughout the Walk-in Wardrobe West Wall. There were no thermal anomalies or any other signs of moisture ingress.

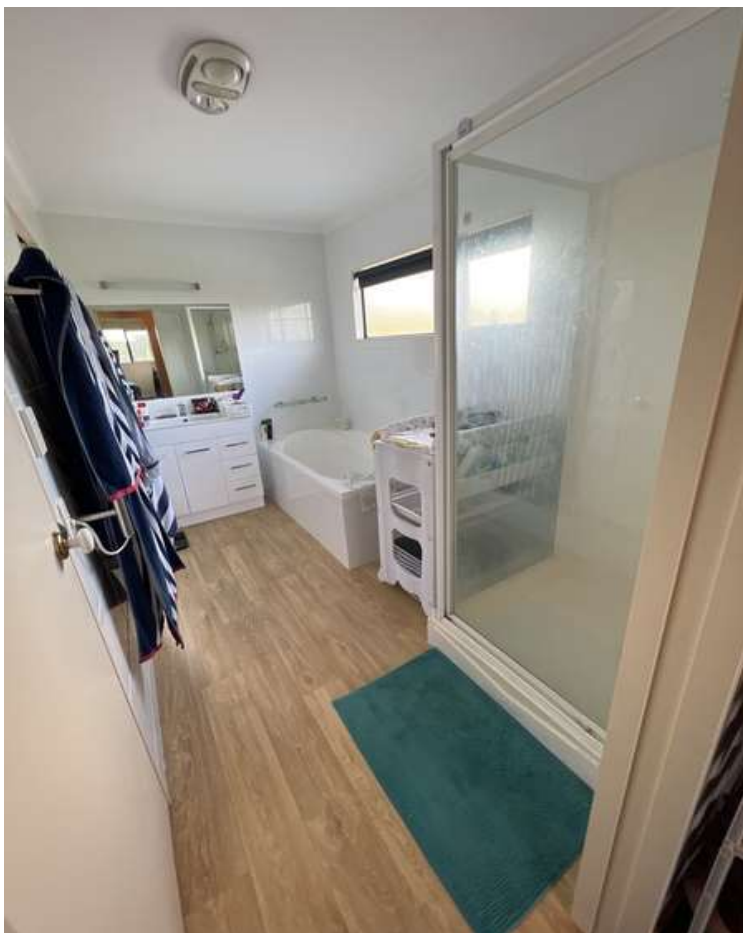
Photo 37

Moisture readings of 12 - 19 % were obtained throughout the Bathroom 2 South-West Wall. There were no thermal anomalies or any other signs of moisture ingress. This area has floor to Ceiling wall tiles with no sign of moisture related issues.

A hot water shower test was carried out to determine if the junctions of the shower were failing. The shower is in good condition.

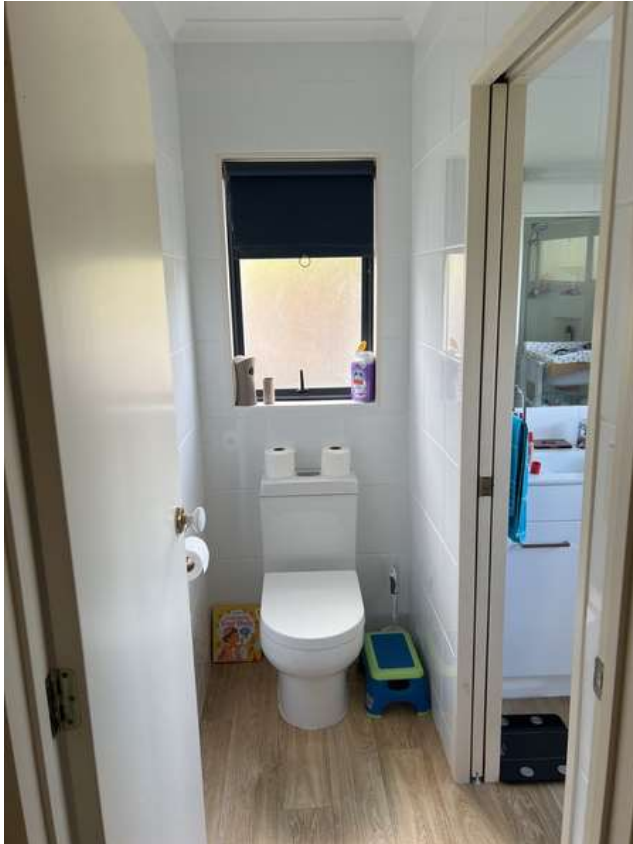
Photo 38

Moisture readings of 12 - 18 % were obtained throughout the Toilet 2 South Wall. There were no thermal anomalies or any other signs of moisture ingress. This area has floor to Ceiling wall tiles with no sign of moisture related issues.

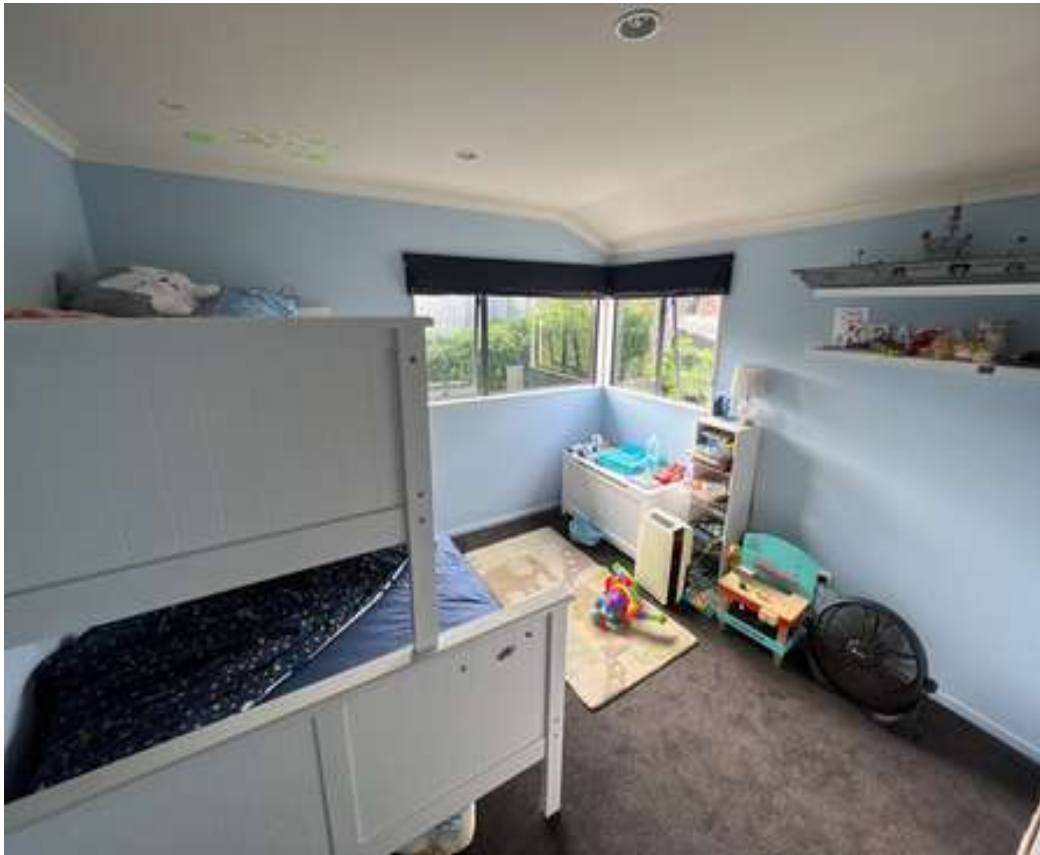
Photo 39

Moisture readings of 11 - 18 % were obtained throughout the Bedroom 4 South-East Wall. There were no thermal anomalies or any other signs of moisture ingress.

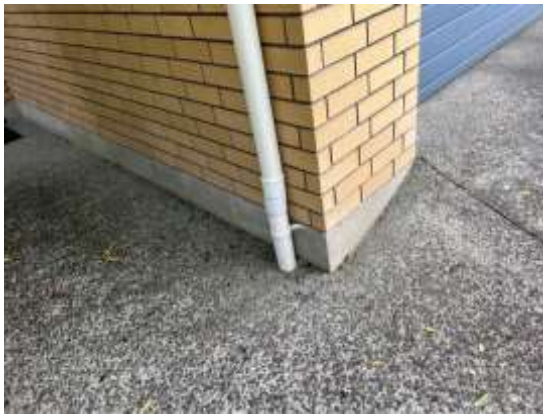
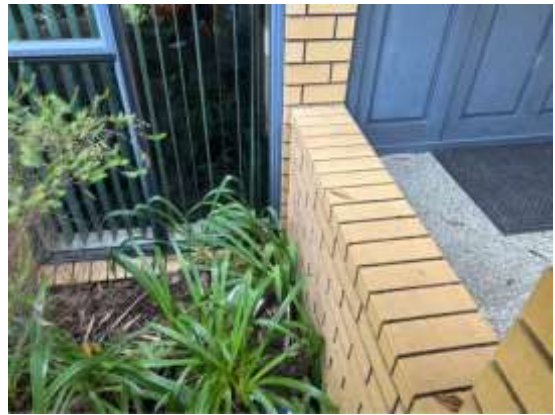
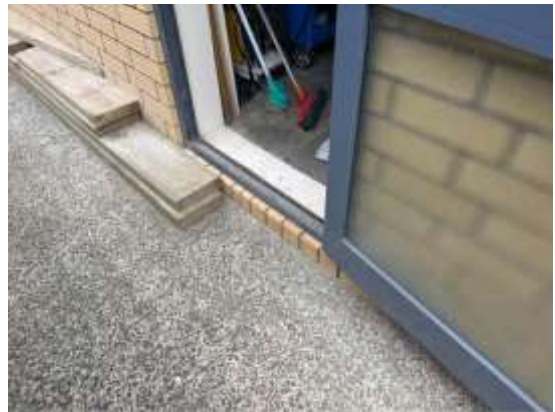
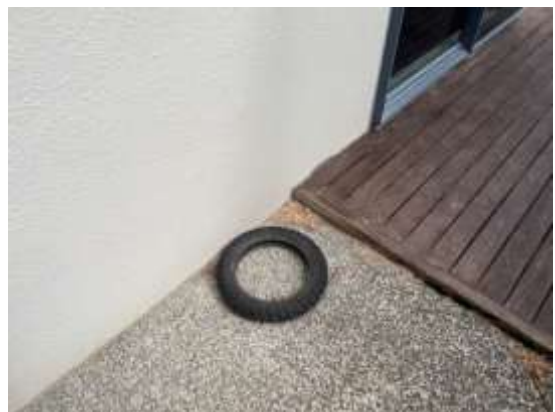
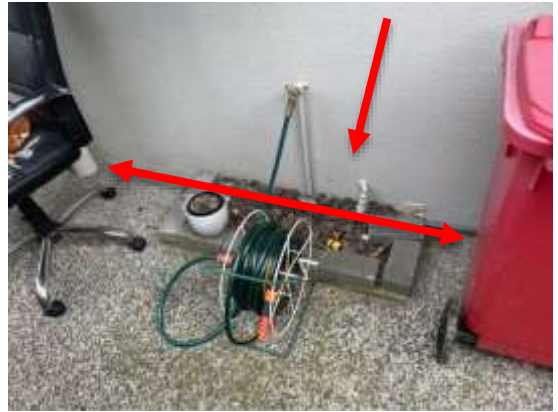
The dwelling has concrete slab floor and foundation with sufficient clearance between the bottom edge of the cladding and the finished ground level throughout most of the dwelling, however there is no cladding clearance in the southeast walls with the plaster cladding below the level of the concrete path and signs of a possible failure into the bottom of the wall in bathroom 1 (photos 40 to 47). Air space clearance is needed.

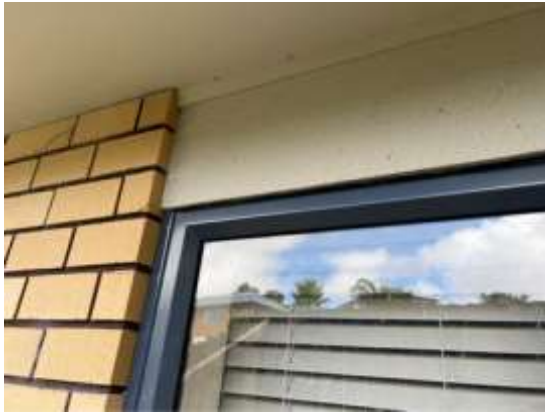
Photo 48

There are head flashings apparent above the windows. The joinery and joinery to cladding junctions are generally in good condition throughout the dwelling, however there is a mitre joint leak in the master bedroom window (photos 48 to 53).

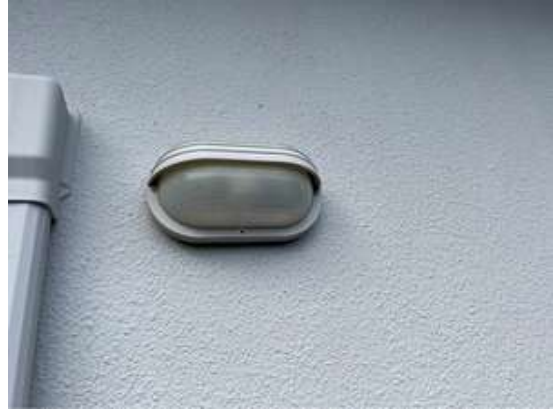
Photo 59

The external light fittings to wall cladding junctions are in good condition (photos 56 to 59).

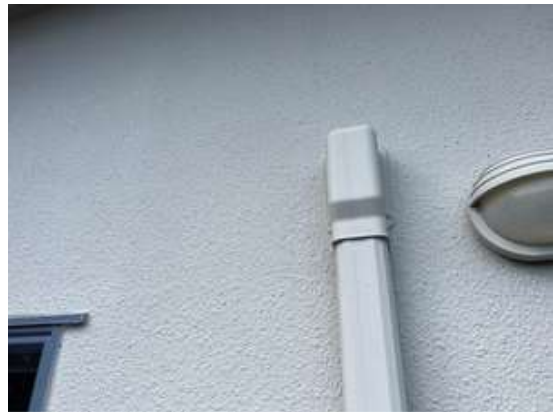
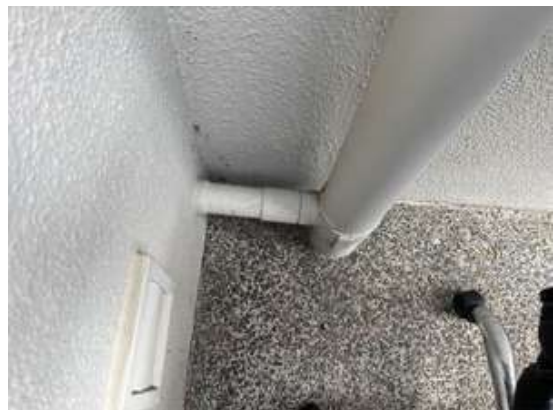
The external taps and pipework to wall cladding junctions are in satisfactory condition with a possible pipe leak at the bottom of bathroom 1 wall that needs checking (photos 60 to 65).

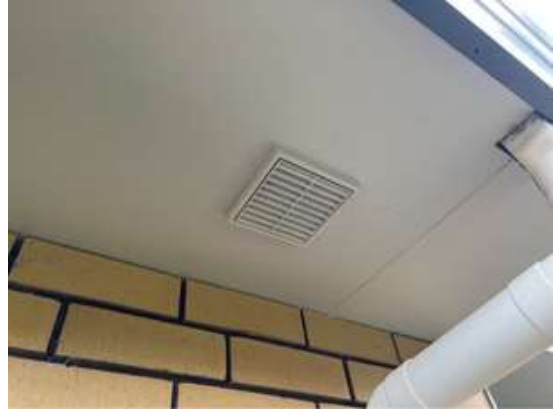
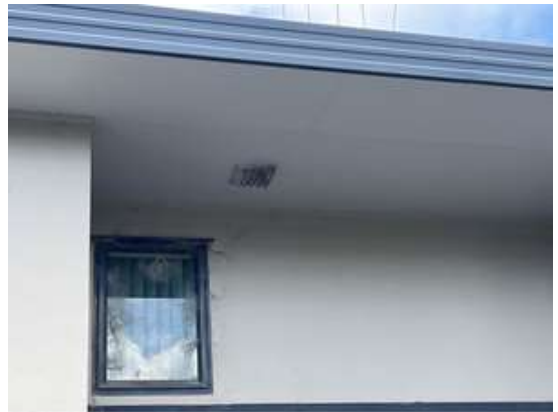
The external extractor vents to wall cladding junction are in good condition (photos 66 to 69).

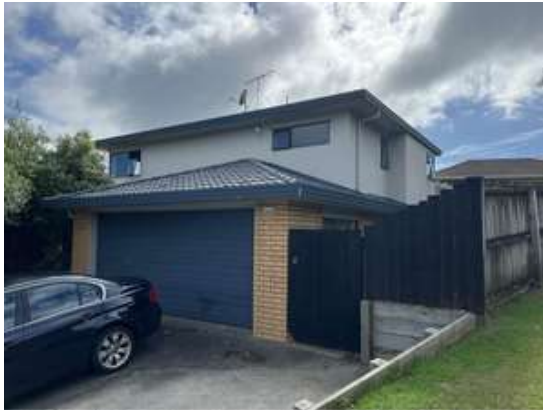
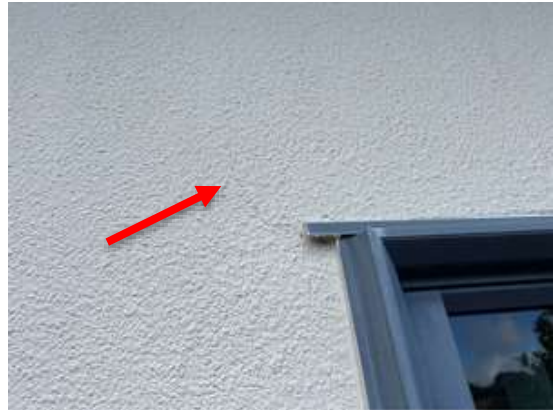
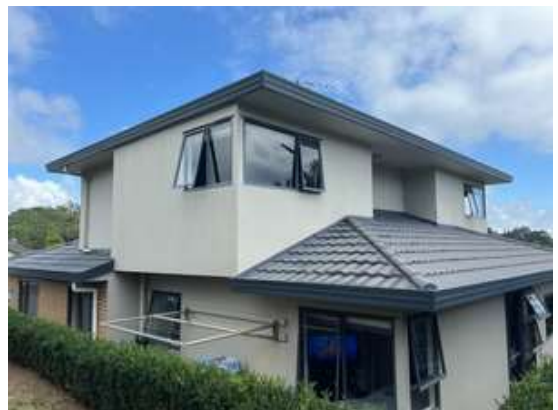
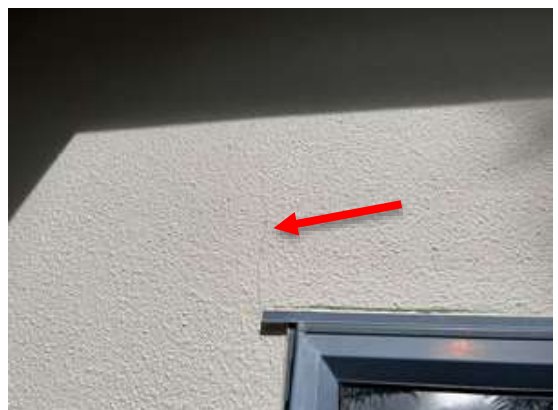
This dwelling is clad with a mix of Brick veneer that is in good condition and non-cavity texture coated fibre-cement board/Harditex type cladding system and has a number of cracks that need remedial attention (photos 72 to 86).

The paint application waterproofs the plaster system and should be repainted every 5 to 7 years to help maintain the plaster cladding. This cladding needs a Chem-wash and a re-paint.

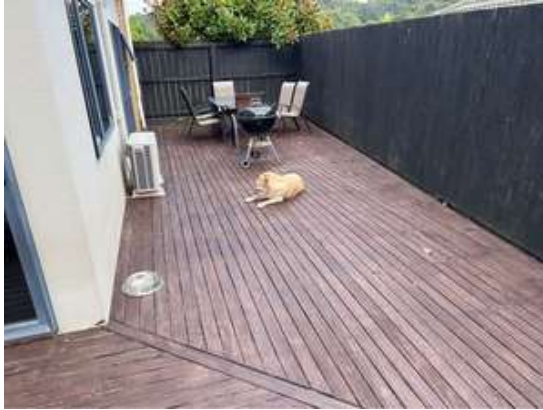
Photo 87

There is a multi-level timber deck that is generally in good condition (photos 87 to 90).

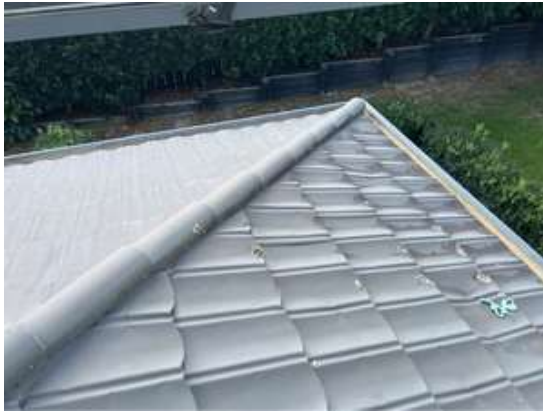
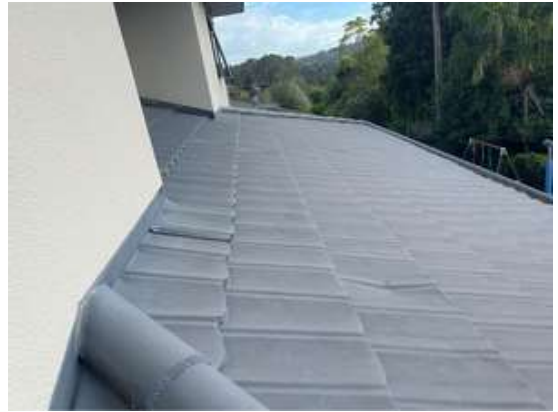
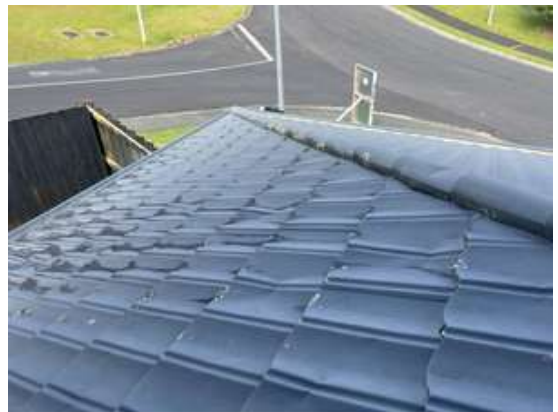
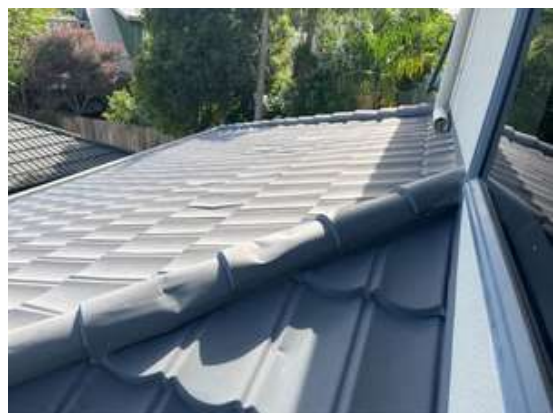
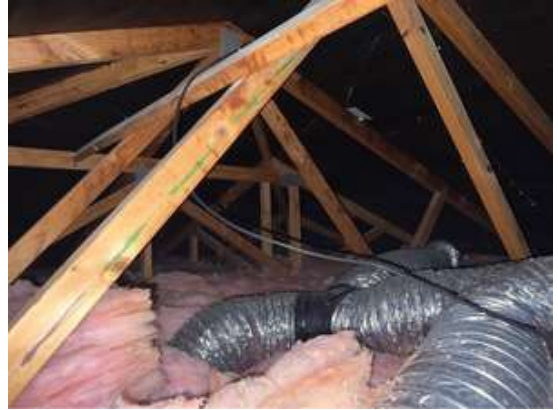
The roof and roof flashing are in a satisfactory condition. There is crease damage from being walked on incorrectly and the roof needs a Chem-wash to remove moss, mould and dirt (photos 97 to 105).

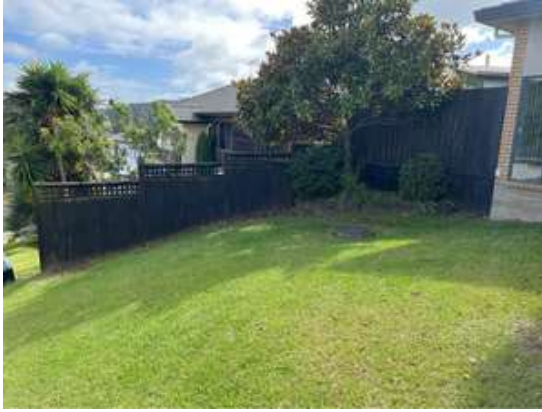
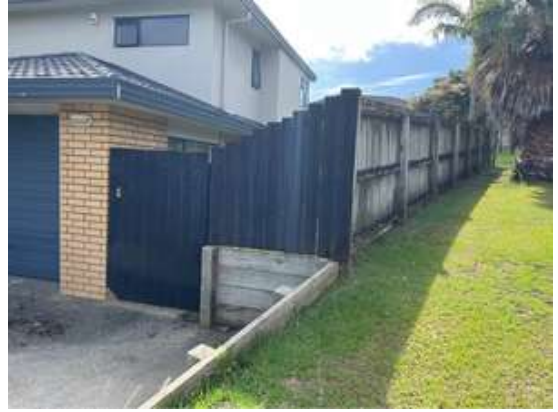
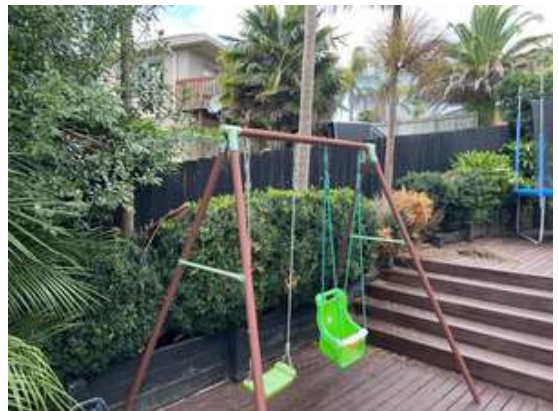
The fences and gates are generally in good condition (photos 112 to 116).

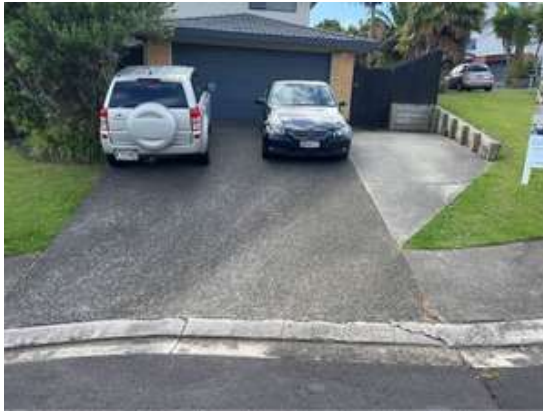
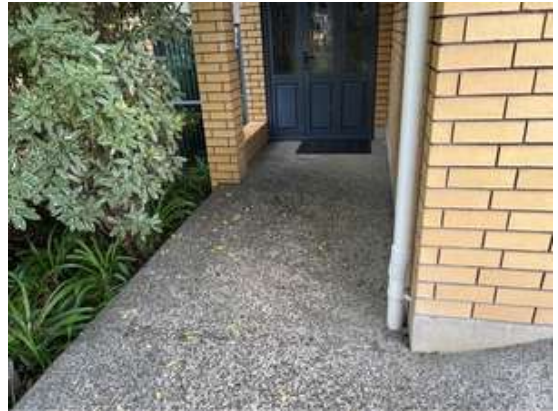
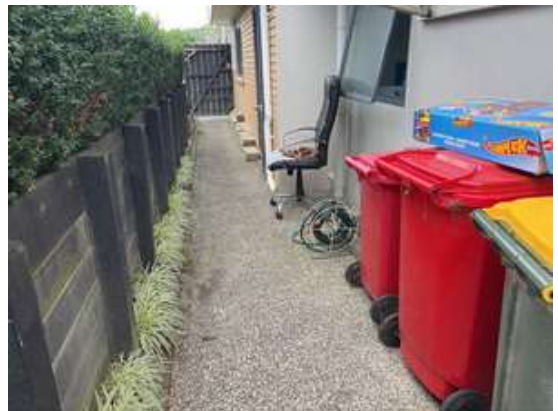
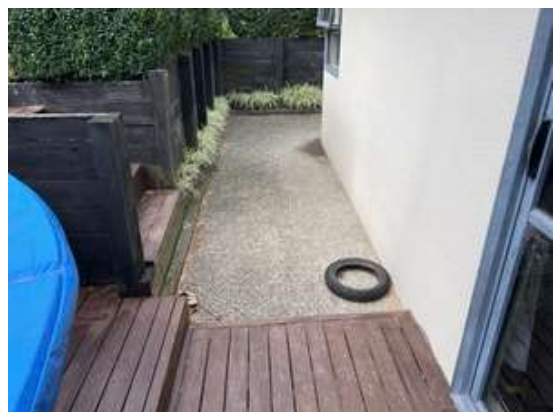
The driveway and paths are in good condition (photos 117 to 122).

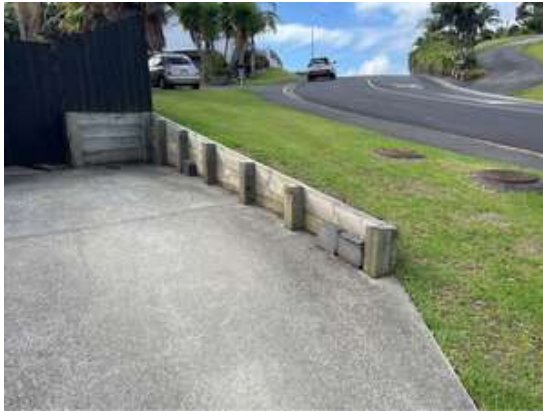
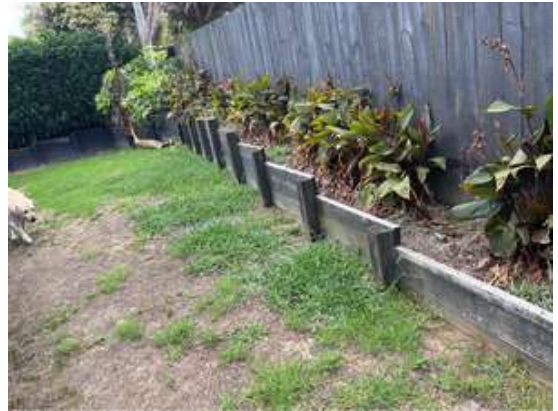
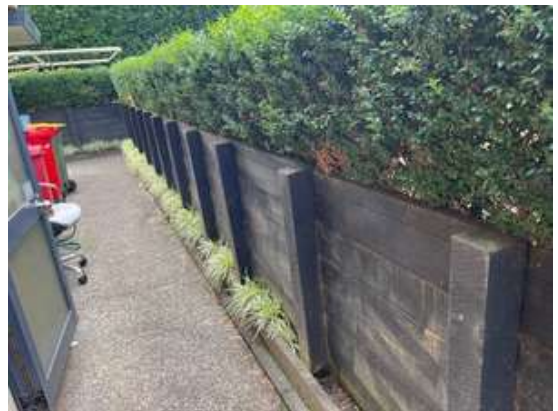
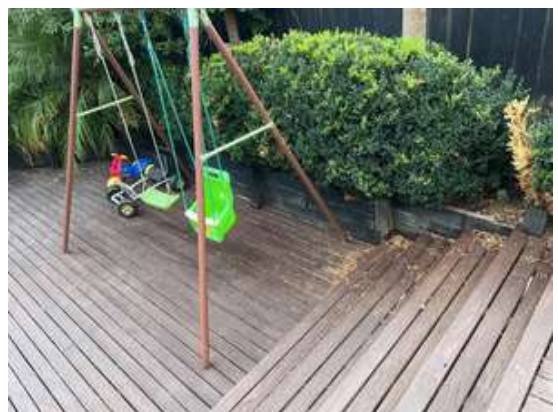
There are timber post and rail garden retaining walls that are in good condition (photos 123 to 128).
