# **DRYSCAN**

**REPORT TYPE:** Track and Trace Moisture Inspection

**DATE OF INSPECTION:** 22/07/2022

Date of Inspection	22/07/2022 at 09:00 AM (12 GMT)
Thermographer	Bryce Hall
Property Address	Auckland
Property Description	7 Storey Apartment Building
Exterior Cladding	Concrete Tilt Slab and Alloy Panels
Roofing Material	Unknown
Joinery	Alloy

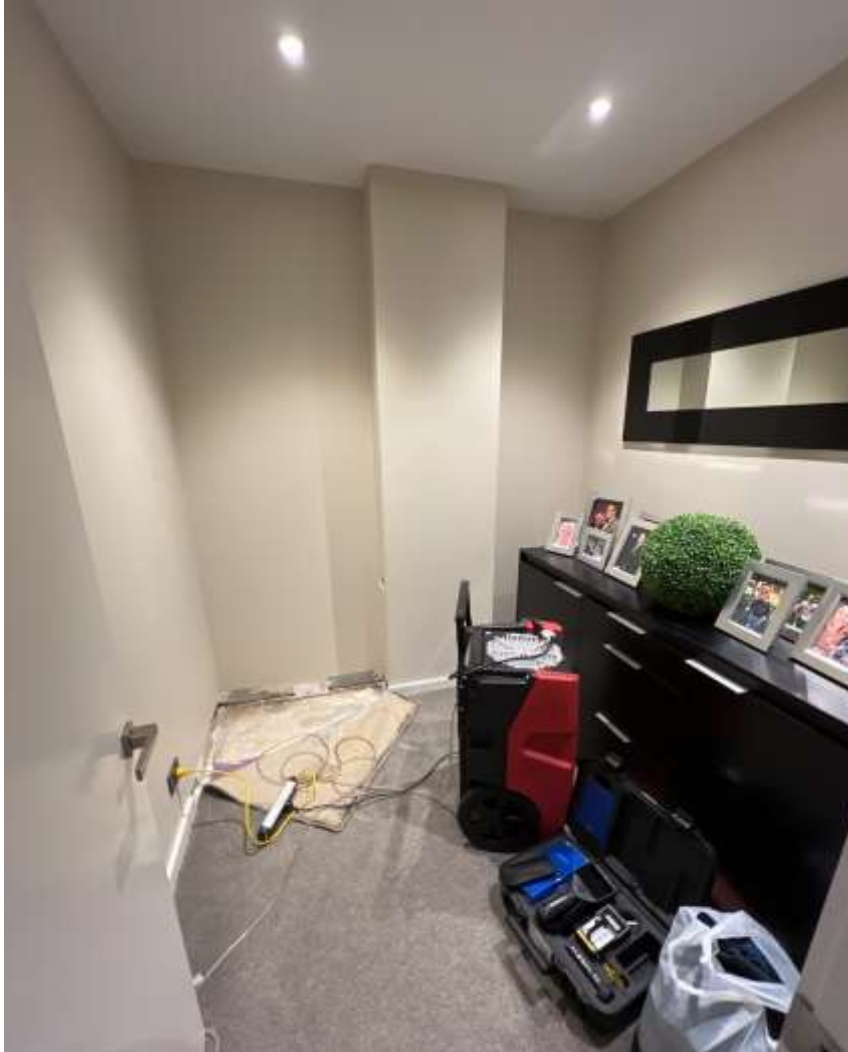
Photo 2

LOCATION: Central Internal Wall

MOISTURE READING %: 08-66

THERMAL ANOMALY: Yes

Soon as Possible

High moisture readings were obtained due to a possible shower waterproofing failure. Due to this, moisture ingress is tracking down/through under the internal wall, giving a reading of 66% at the bottom on the left hand side with signs of seepage along the concrete floor inside the wall cavity between apartments 304 and 301 on the other side of this wall (photos and thermal images 3 to 7).

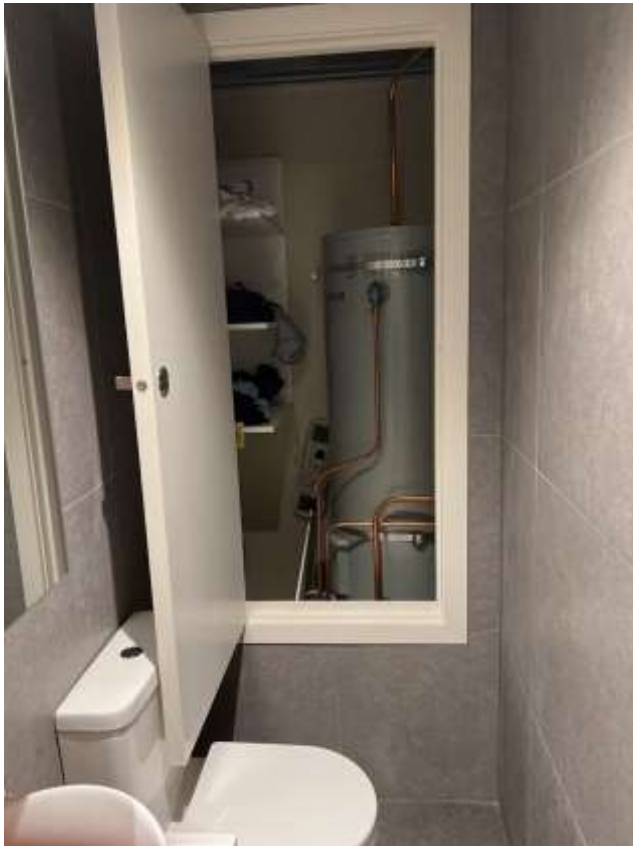
Photo 8

LOCATION: Central Internal Wall

MOISTURE READING %: 08

THERMAL ANOMALY: Yes

**Soon as Possible**

There are signs of seepage due to a possible shower waterproofing failure at the bottom on the left hand side inside the cupboard with moisture on the concrete floor coming out under the wall cavity between apartments 304 and 301 on the other side of this wall (photos and thermal images 9 to 11).

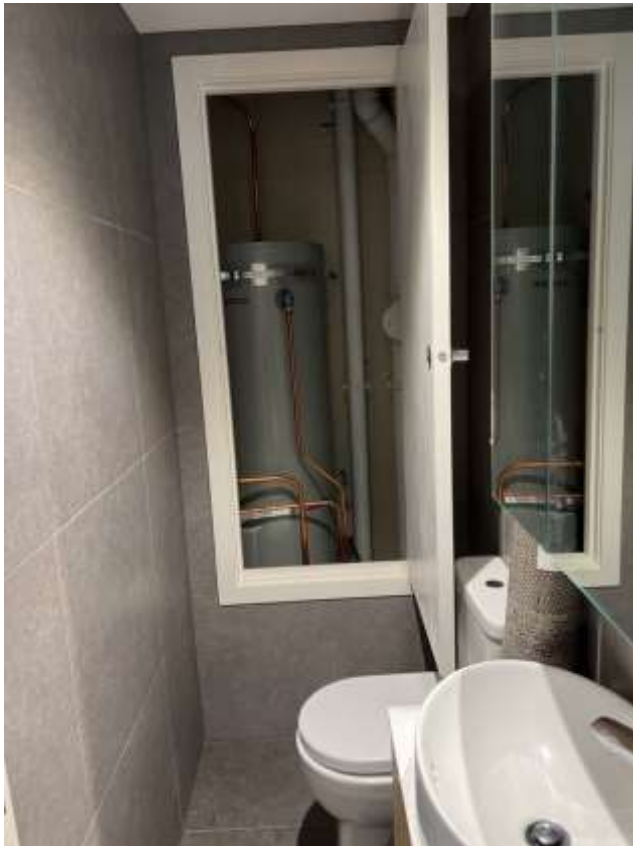
Photo 12

LOCATION: Central Internal Wall

MOISTURE READING %: 08

THERMAL ANOMALY: Yes

**Soon as Possible**

There are signs of seepage due to a possible shower waterproofing failure at the bottom on the right hand side inside the cupboard with moisture on the concrete floor coming out under the internal wall between the Toilet/HWC and the Bathroom/Laundry on the other side of this internal wall with a moisture at the bottom of the HWC growing large in the thermal image when a water test was carried out on the tiled shower tray (photos and thermal images 9 to 11). This issue appears to seeping under the wall between apartments this apartment 301 and to the other side of this wall that is apartment 304. Level 2 apartments below need to be checked for seepage down the building.

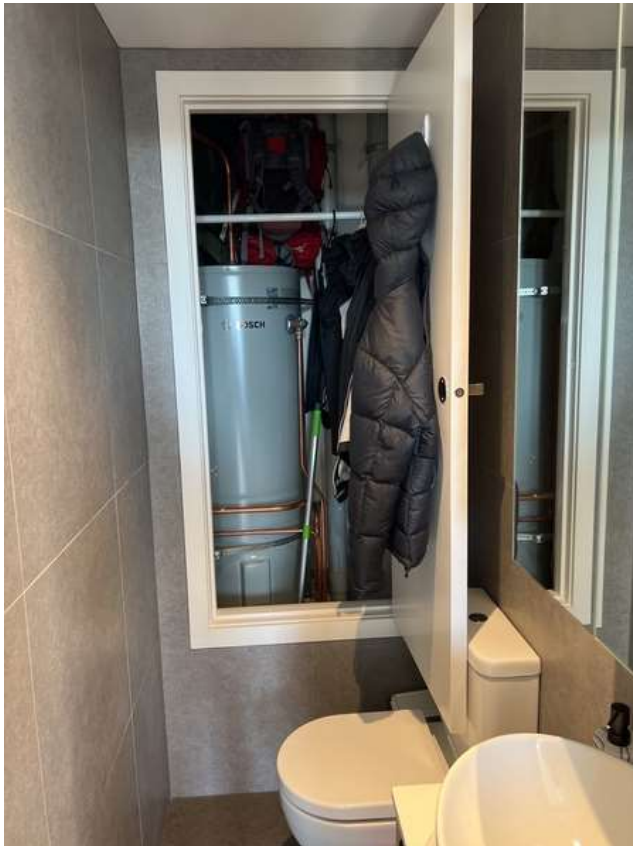
Photo 21

LOCATION: Central Internal Wall

MOISTURE READING %: 08

THERMAL ANOMALY: Yes

**Soon as Possible**

In checking level 2 below the leaks found on level 3 there was found to seepage down through the floor around pipe penetrations and cracks in the floor that can be seen at the top inside the HWC (photos and thermal images 22 to 25).

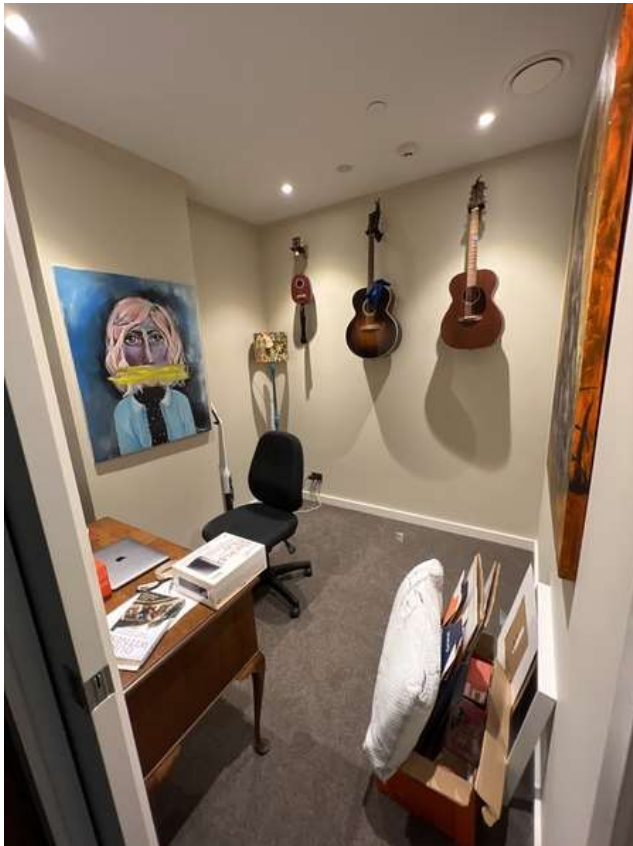
Photo 26

LOCATION: Central Internal Wall

MOISTURE READING %: 08-92

THERMAL ANOMALY: Yes

**Soon as Possible**

In checking the Study there was found to be high moisture readings on the ceiling at the top of the wall backing onto apartment 204. This also due to the waterproofing failure tracking down/through the floor/ceiling between level 2 and 3, giving a reading of 46 to 92% at the top on the left hand side (photos and thermal images 27 to 30). The other side of this wall apartment 204 needs to be checked also!

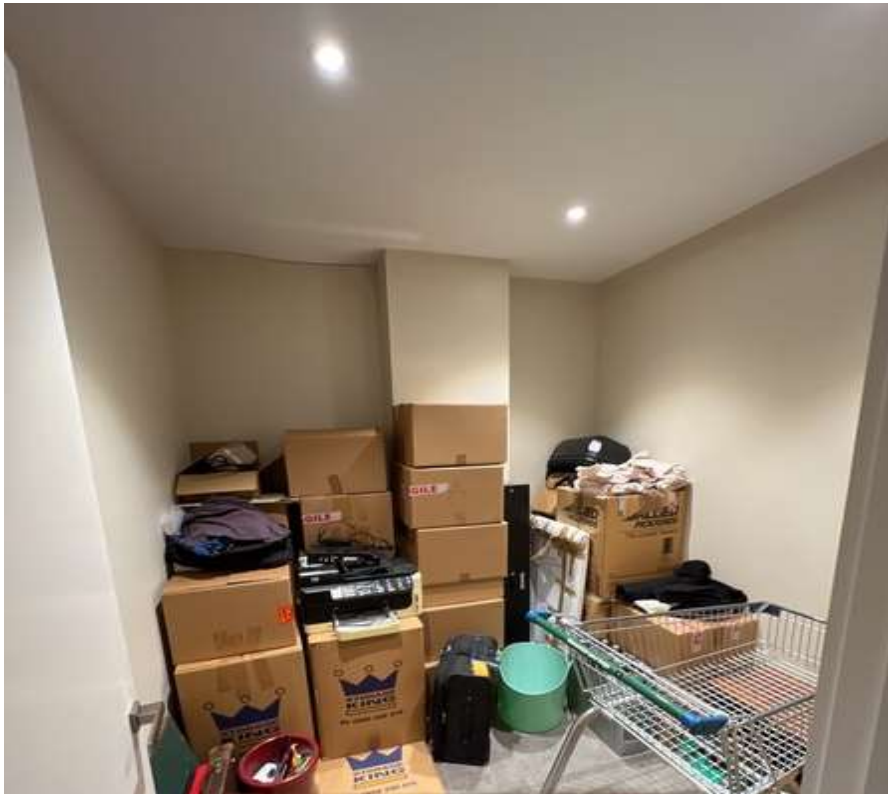
Photo 31

LOCATION: Central Internal Wall

MOISTURE READING %: 08 - 90

THERMAL ANOMALY: Yes

**Soon as Possible**

High moisture readings were obtained due to waterproofing failure, located above here. Due to this, moisture ingress is tracking down/through the upper floor level to the ceiling that is badly moisture damage and sagging, giving a reading of 90% at the top on the left hand side of the column (photos and thermal images 32 to 35). This is same issue as in the Study of 201 on the other side of this wall.
