# **DRYSCAN**

**REPORT TYPE:** Track and Trace Moisture Inspection

**DATE OF INSPECTION:** 22/07/2022

Date of Inspection	22/07/2022 at 09:00 AM (12 GMT)
Thermographer	Bryce Hall
Property Address	Auckland
Property Description	7 Storey Apartment Building
Exterior Cladding	Concrete Tilt Slab and Alloy Panels
Roofing Material	Unknown
Joinery	Alloy

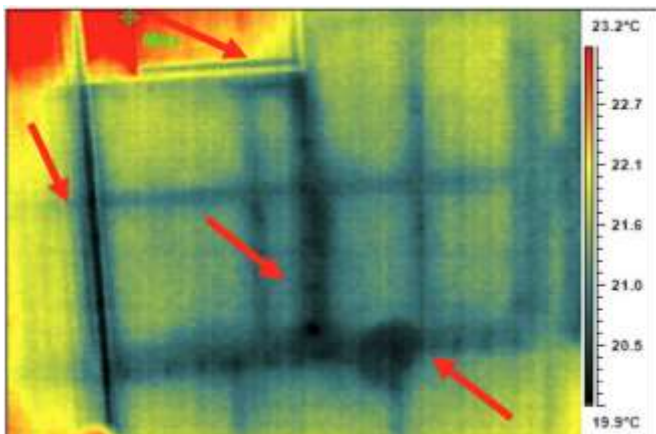
This image shows a significant difference and inconsistent distribution in colour / temperatures which would indicate the presence of a thermal anomaly and would require further investigation.

Here the internal wall framing is visible, with warmer areas being highlighted in yellow and colder areas in purple/grey.

The colder purple/grey areas in this thermal image show a window leak tracking down inside this wall and would be an area of concern and a recommendation for further investigation would be expressed.
