DRYSCAN

REPORT TYPE: Pre-Purchase Building and Weather
Tightness Inspection

DATE OF INSPECTION: 00/00/2022

Date of Inspection	00/00/2022 at 09:05 AM (13 GMT)
Thermographer	Bryce Hall
Property Address	Auckland.
Property Description	Attached, 2 Storey Dwelling
Exterior Cladding	Brick and Direct Fixed Texture Coated Fibre-cement Board/Harditex type
Roofing Material	Tin Tiles
Joinery	Alloy

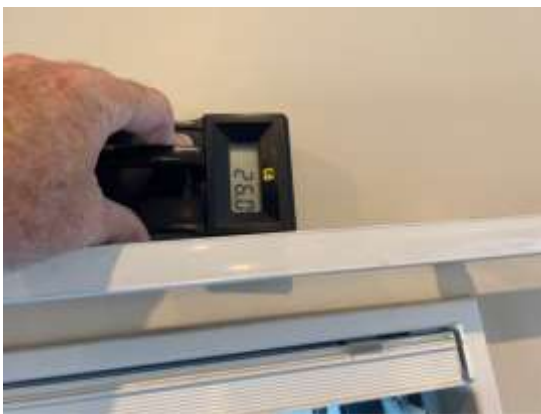
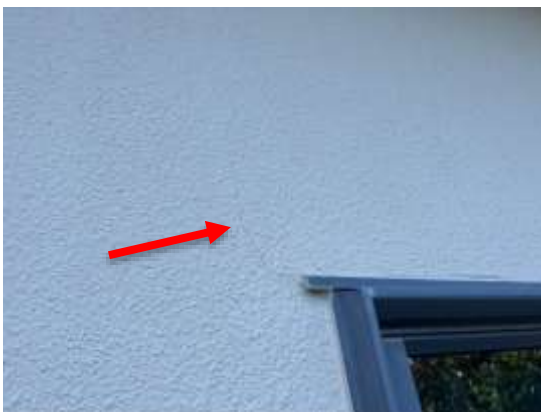
High moisture readings were obtained due to cladding failure, located outside here. Due to this, moisture ingress is tracking down/through the internal wall, giving a reading of 26% at the top above the doors on the right hand side (photos and thermal images 5 to 10).

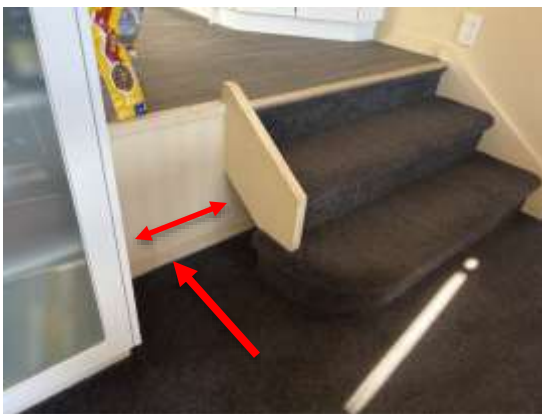
Photo 14

High moisture readings were obtained due to waterproofing failure. Due to this, moisture ingress is tracking through the floor slab split level by the steps to the kitchen, giving a reading of 61% at the bottom on the left hand side of the steps (photos and thermal images 12 to 15).

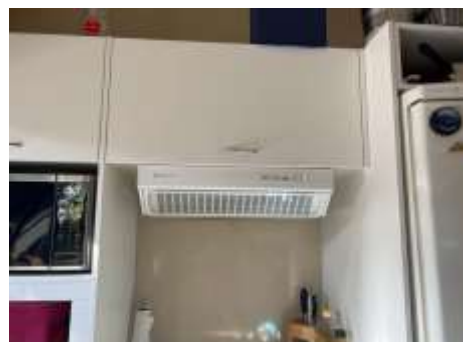
Photo 18

Kitchen Sink Plumbing appears to be in good working order, the rangehood is ducted outside (photos 17 & 18).

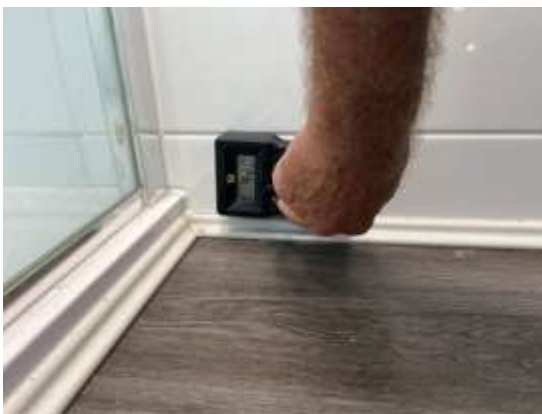
This area has floor to Ceiling wall tiles with high moisture readings were obtained due to a possible pipe or ground clearance failure, located outside here. Due to this, moisture ingress is tracking down/through the internal wall, giving a reading of 94% at the bottom of the wall below the window (photos and thermal images 22 to 25).

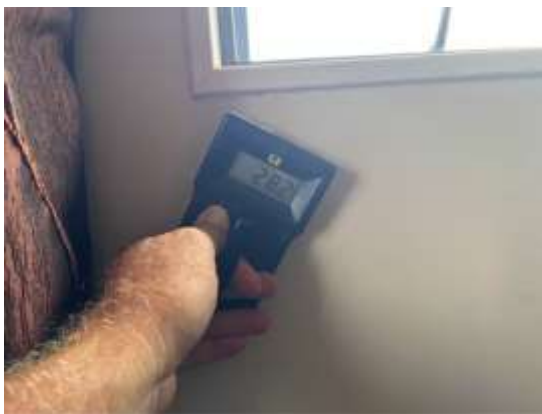
High moisture readings were obtained due to a joinery failure, located outside here. Due to this, moisture ingress is tracking down/through the internal wall, giving a reading of 28% under the north wall window on the left hand side (photos and thermal images 33 to 35).

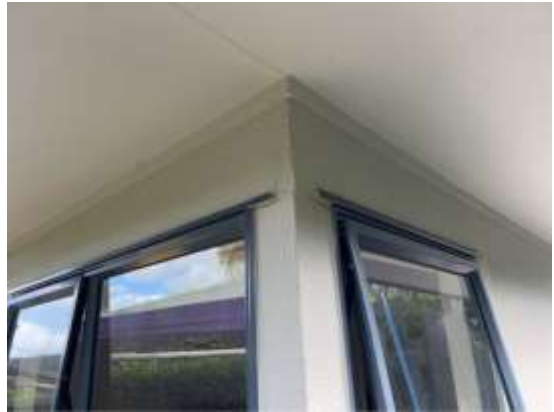
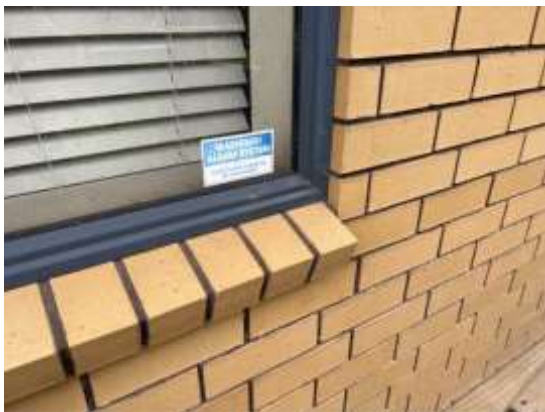
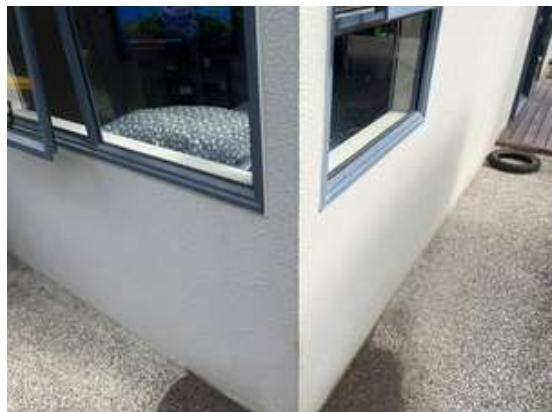
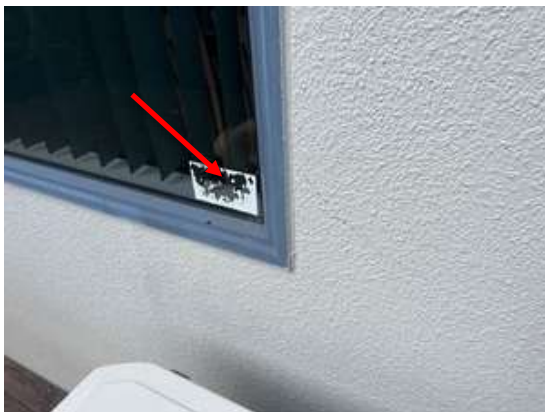
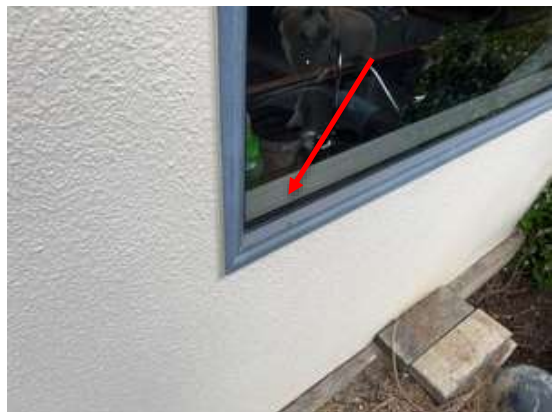
There are head flashings apparent above the windows. The joinery and joinery to cladding junctions are generally in good condition throughout the dwelling, however there is a mitre joint leak in the master bedroom window (photos 48 to 53).

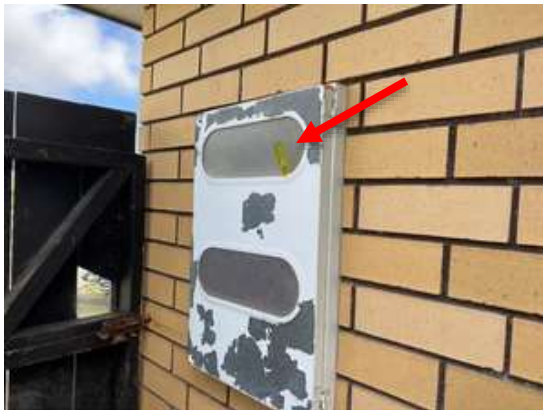
Photo 54

The windows of the power meter box need to be properly sealed in place (photo 54).

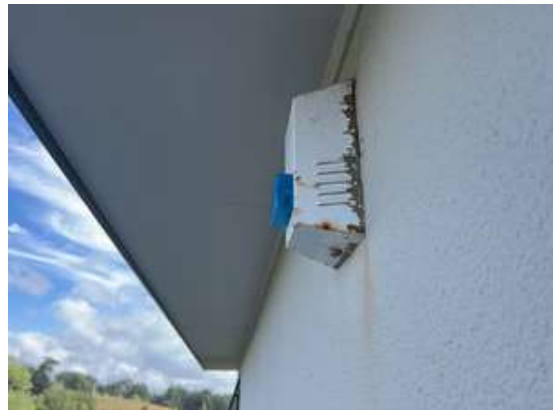
Photo 55

The external alarm to wall cladding junction is in satisfactory condition (photo 55).

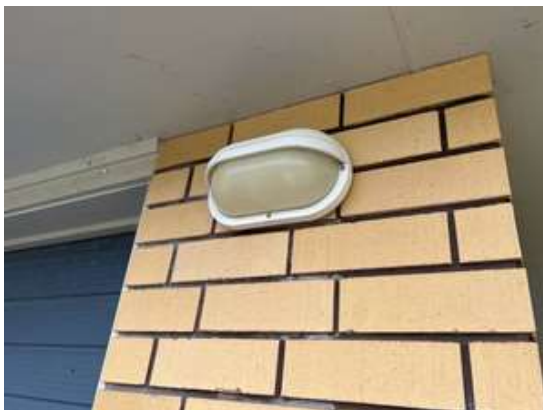
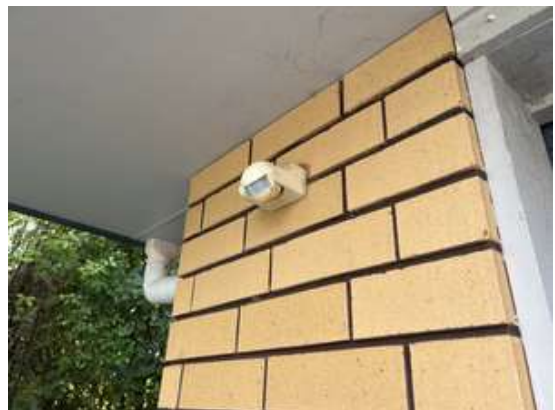
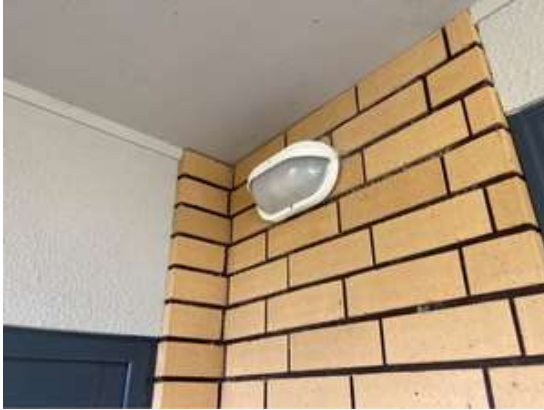
The external light fittings to wall cladding junctions are in good condition (photos 56 to 59).

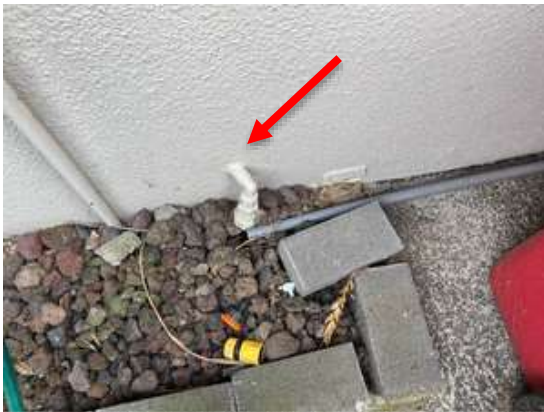
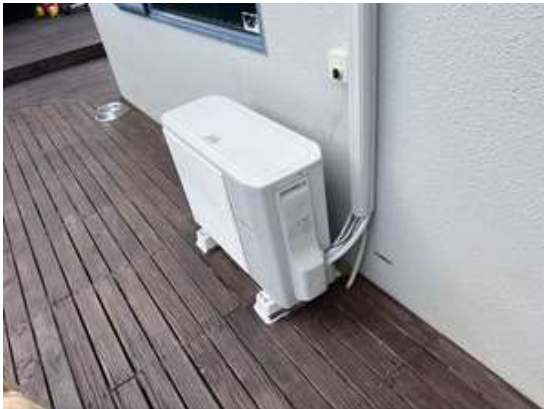
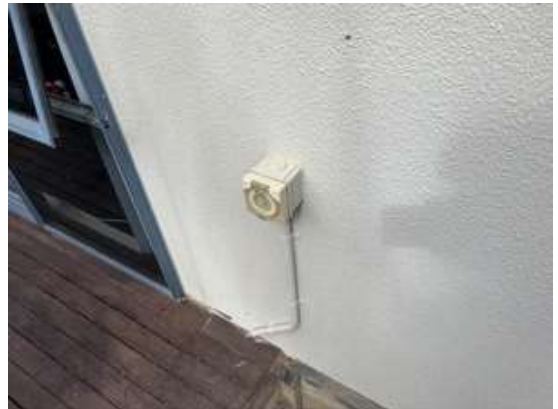
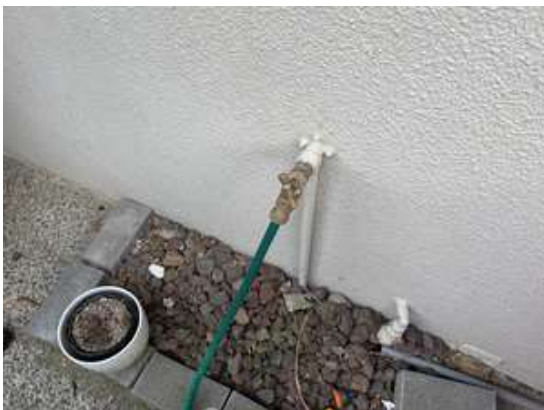
The external taps and pipework to wall cladding junctions are in satisfactory condition with a possible pipe leak at the bottom of bathroom 1 wall that needs checking (photos 60 to 65).

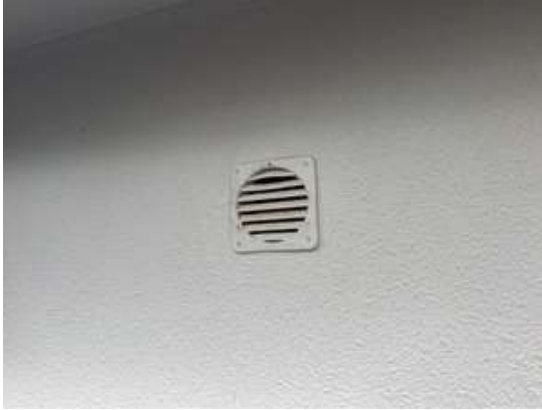
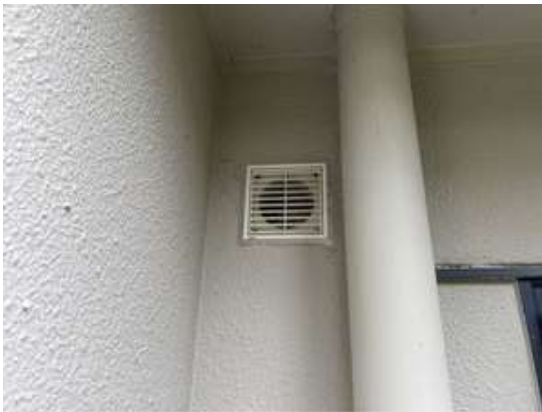
The external extractor vents to wall cladding junction are in good condition (photos 66 to 69).

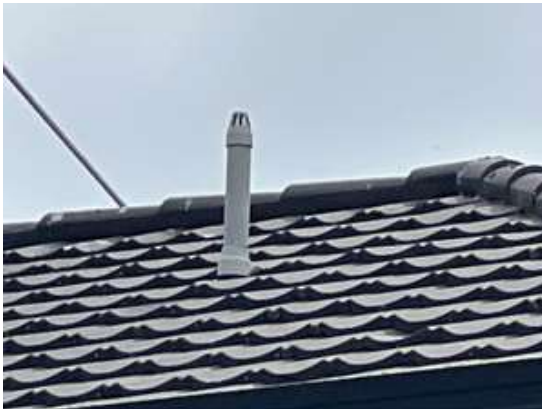
Photo 70

The vent pipe to roof flashing was found to be in good condition (photo 70).

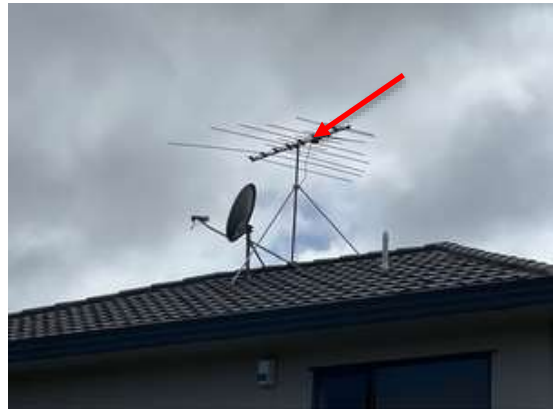
Photo 71

The sky dish and TV aerial to roof penetration were in good condition at the time of our investigation (photo 71). We recommend that this is removed as is now obsolete.

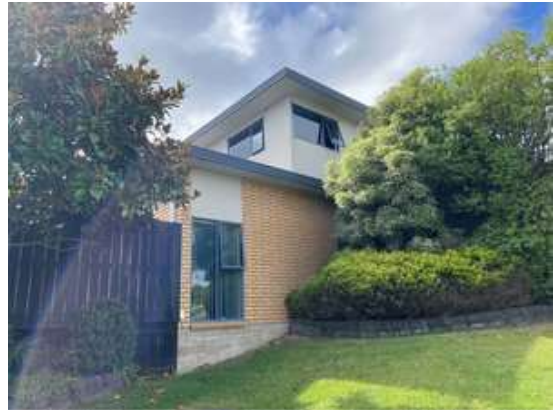
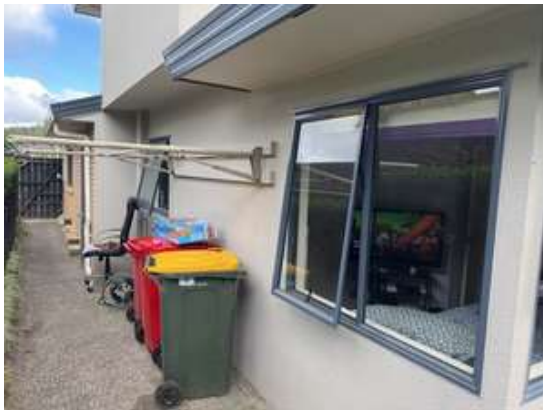
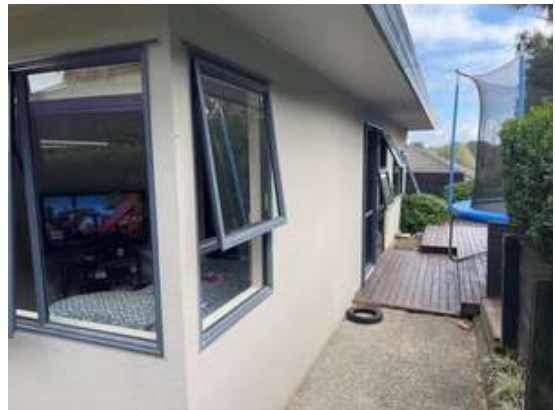
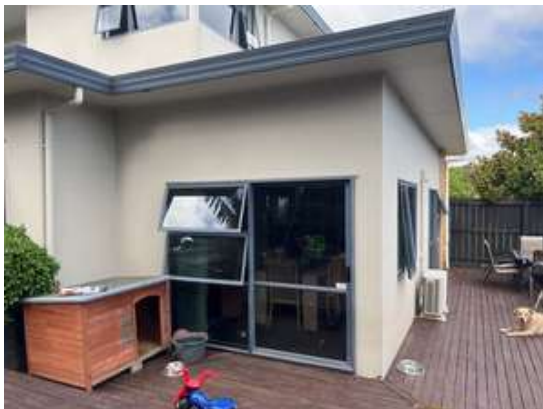
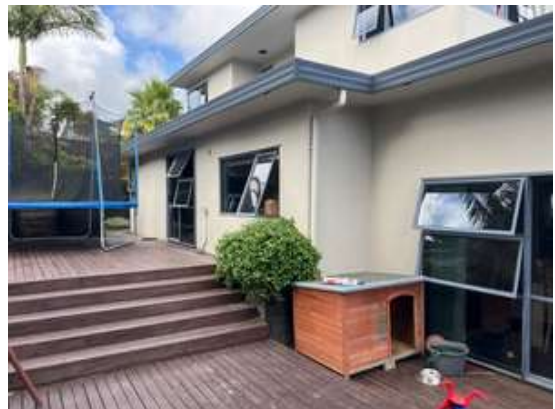
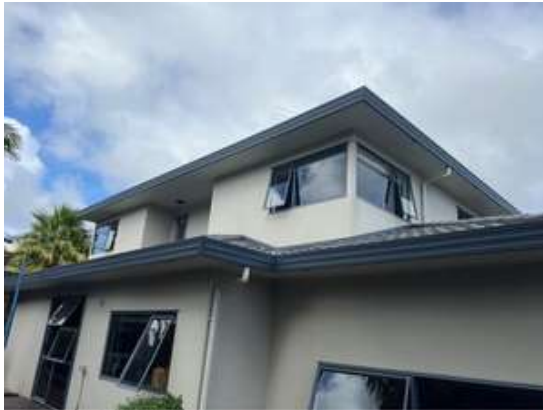
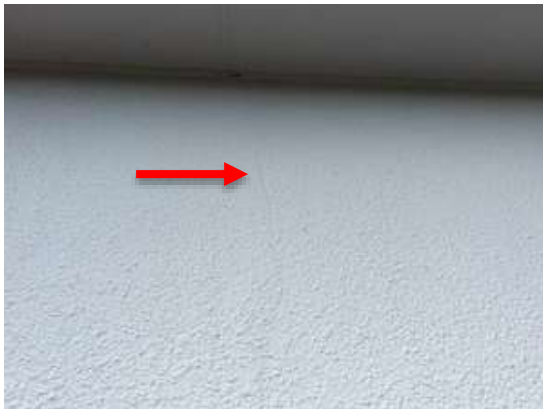
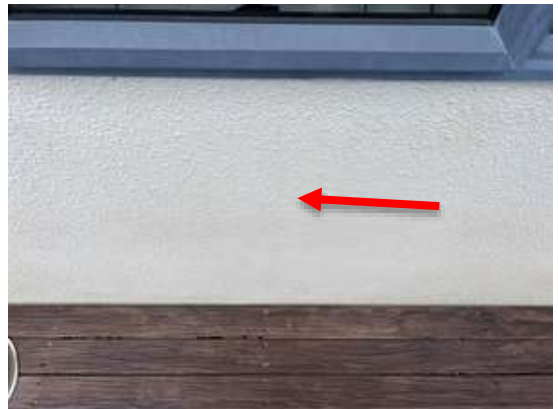
This dwelling is clad with a mix of Brick veneer that is in good condition and non-cavity texture coated fibre-cement board/Harditex type cladding system and has a number of cracks that need remedial attention (photos 72 to 86).

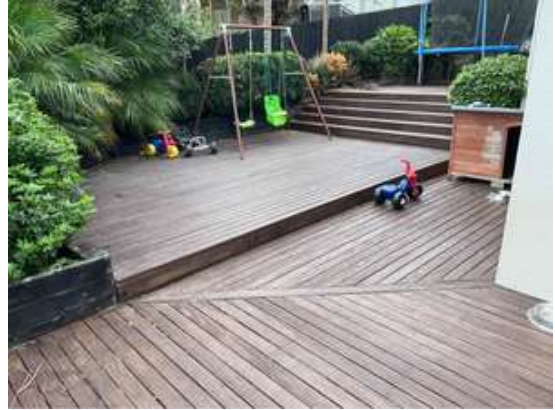
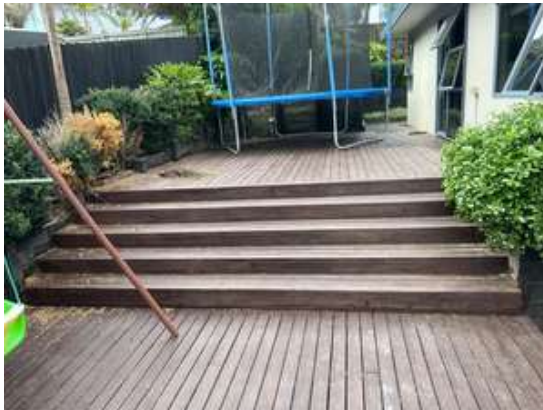
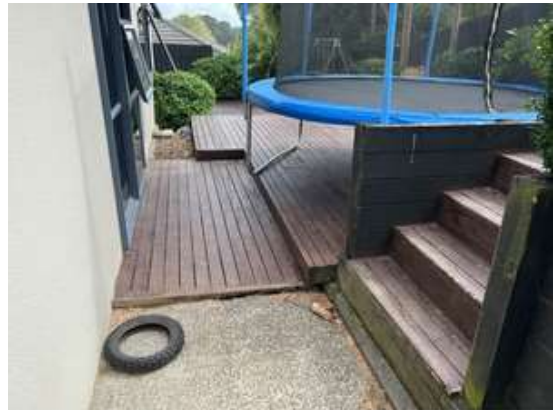
There is a multi-level timber deck that is generally in good condition (photos 87 to 90).

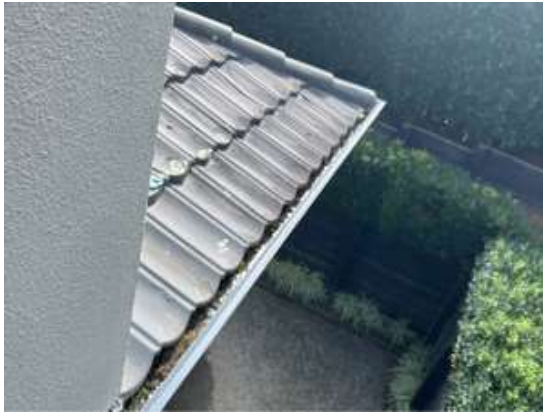
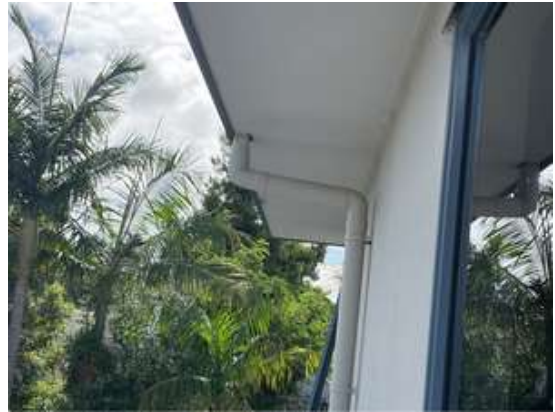
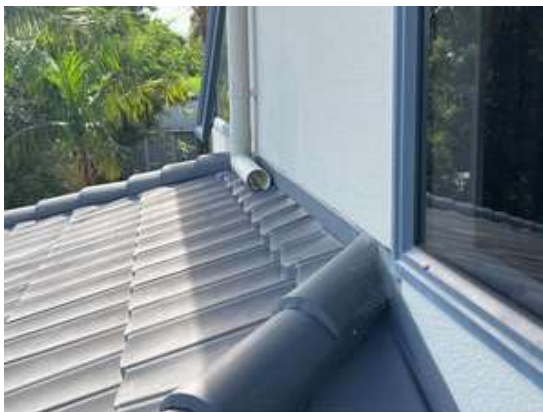
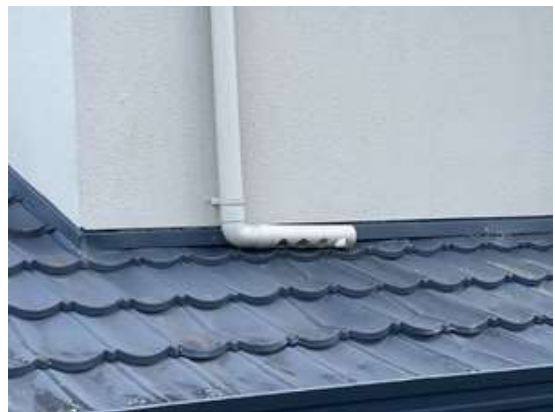
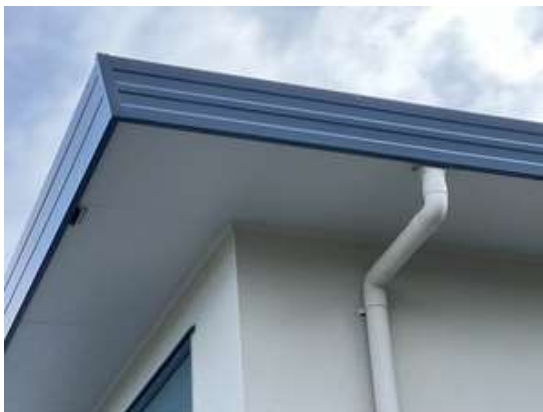
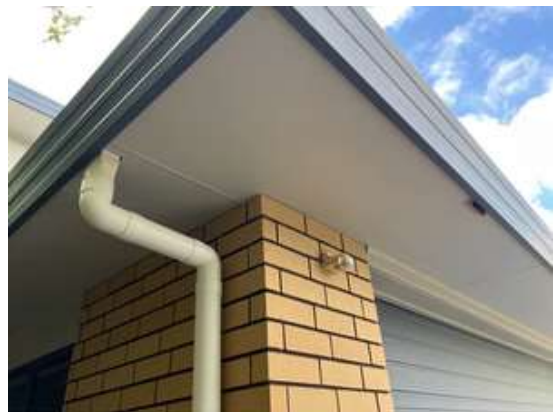
This dwelling has Klass/Taylor enclosed gutter system, can flood the soffits in heavy rain fall. There are overflow outlets and spreaders in place on the upper roof areas. Some gutters need clearing and cleaning (photos 91 to 96).

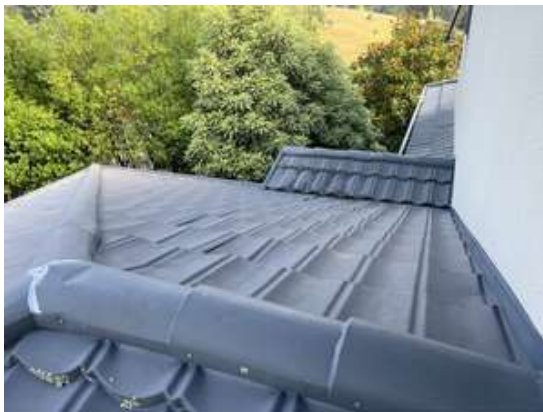
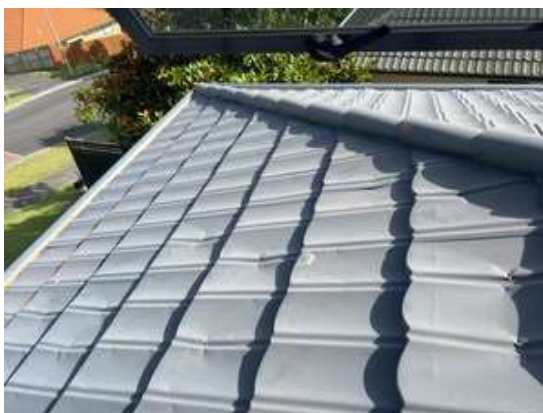
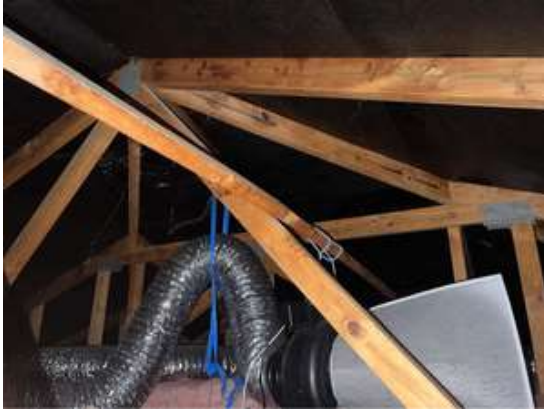
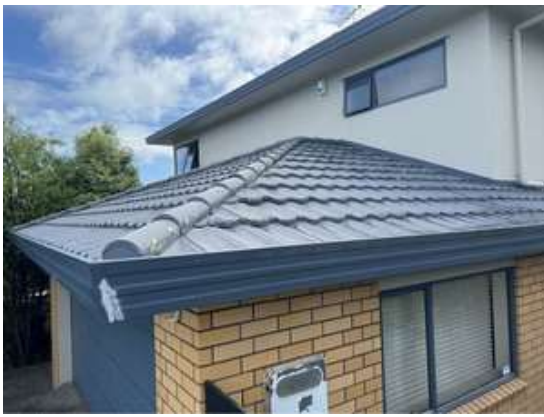
The roof and roof flashing are in a satisfactory condition. There is crease damage from being walked on incorrectly and the roof needs a Chem-wash to remove moss, mould and dirt (photos 97 to 105).

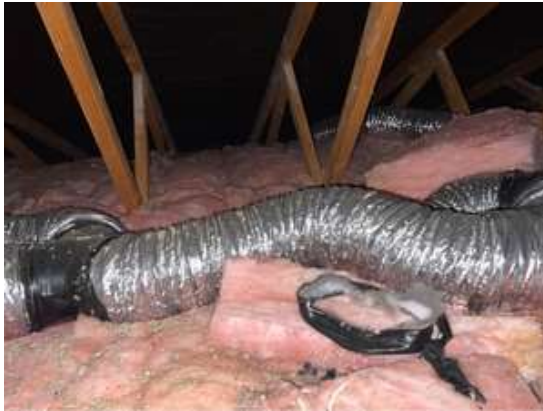
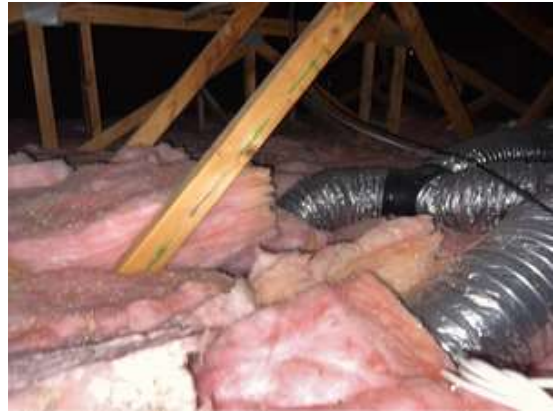
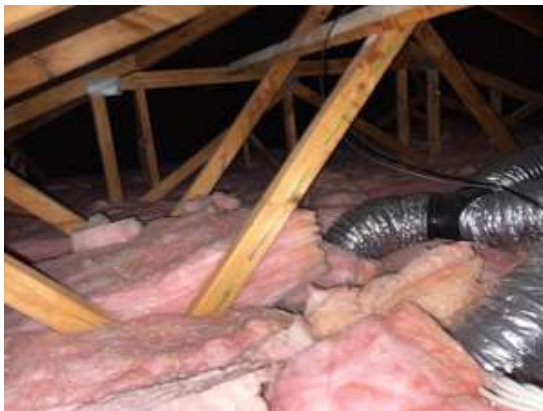
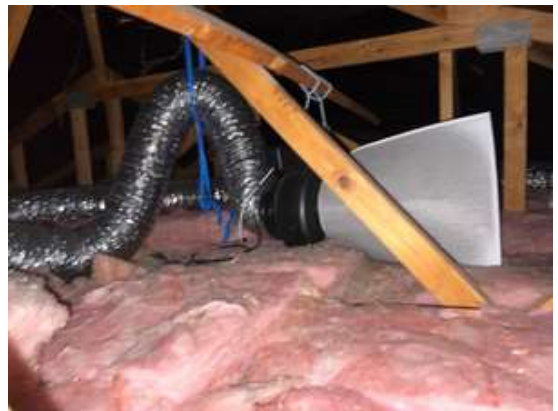
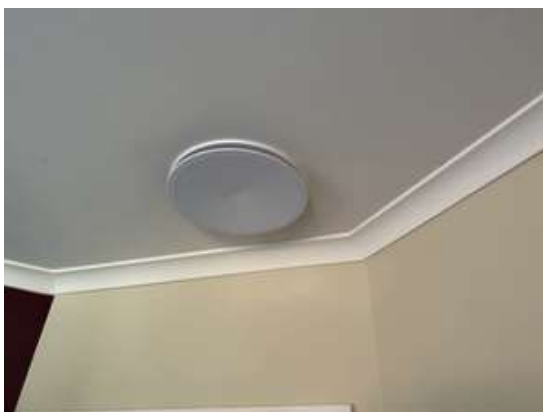
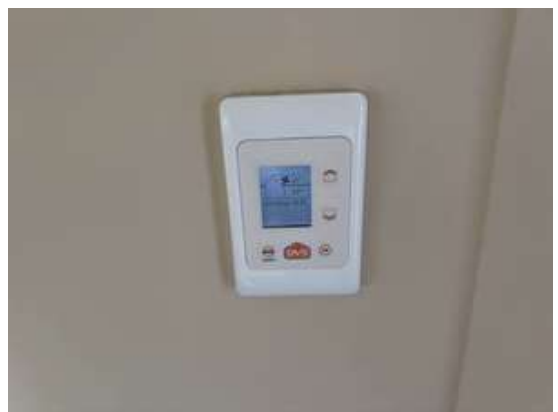
There is ceiling Insulation and a DVS ventilation system in place (photos 106 to 111).

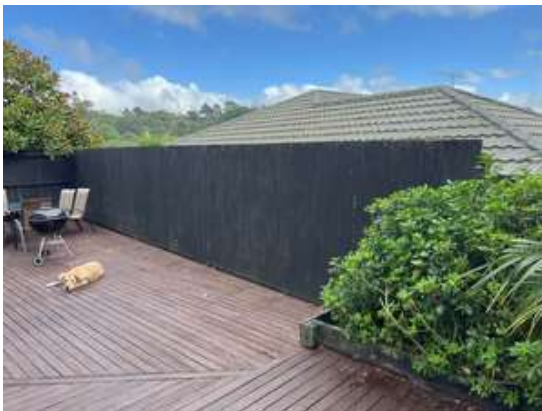
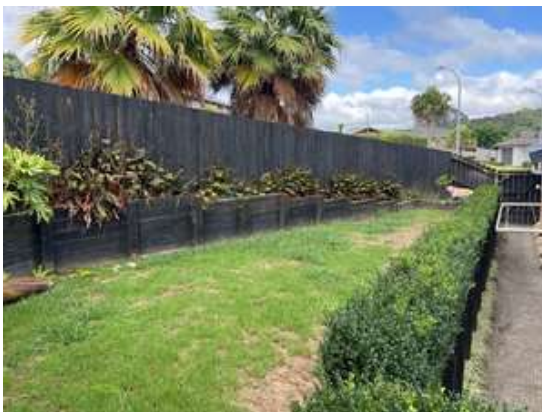
The fences and gates are generally in good condition (photos 112 to 116).

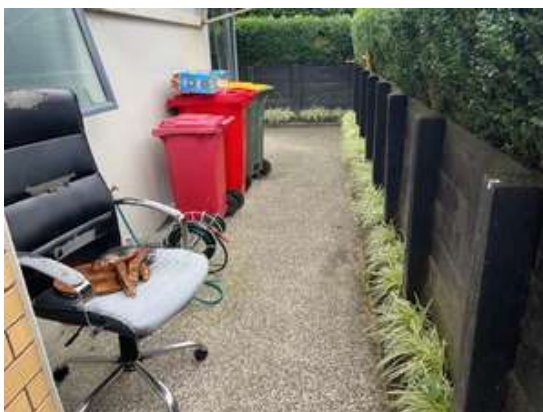
The driveway and paths are in good condition (photos 117 to 122).

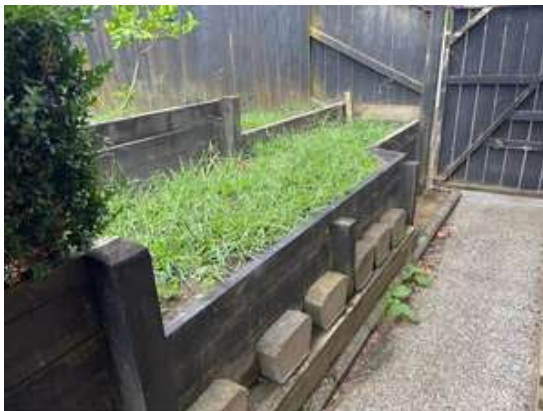
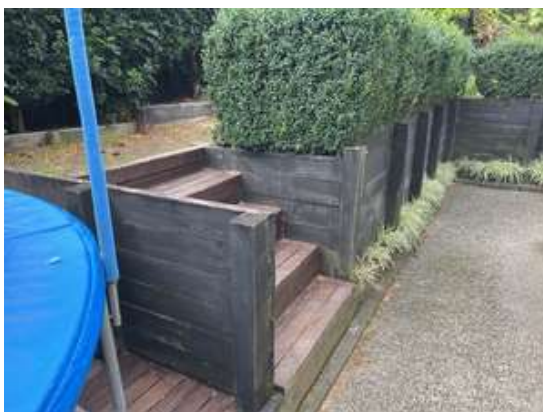
There are timber post and rail garden retaining walls that are in good condition (photos 123 to 128).
